Wasatch Commons Condo Association

Level 2 Reserve Study

Report Period – 01/01/2023 – 12/31/2023

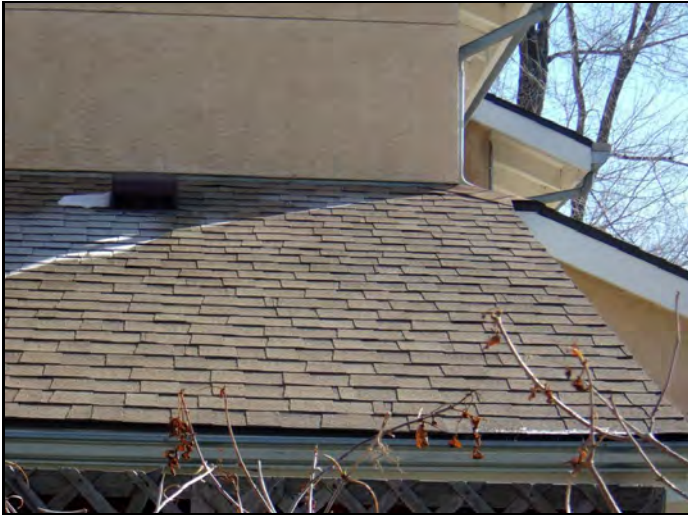
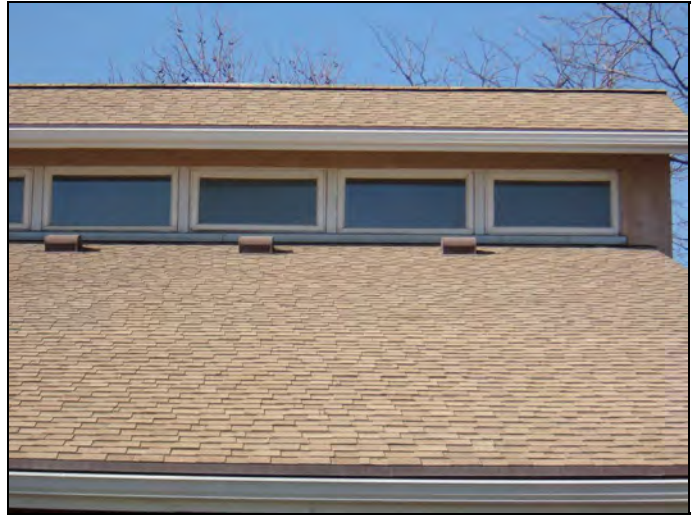
Comp #: 105 Roofs - 2012 - Replace

The roofs are in good condition. We recommend funding to replace this component approximately every 20 - 25 years. Remaining life based on current age.

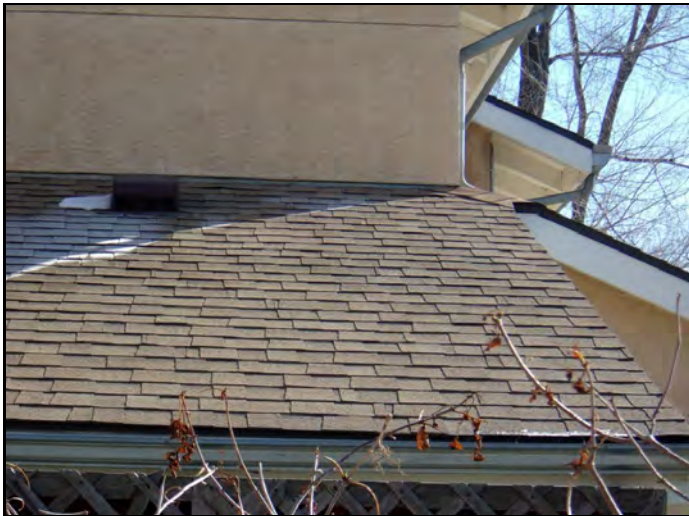
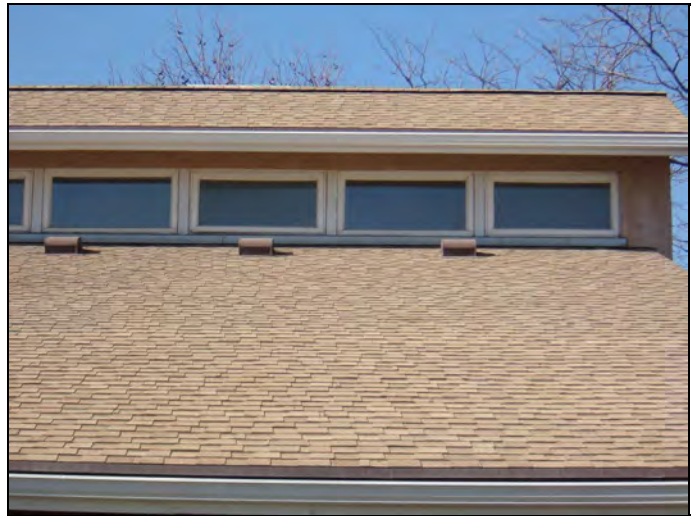
Comp #: 105 Roofs - 2014 - Replace

The roofs are in good condition. We recommend funding to replace this component approximately every 20 - 25 years. Remaining life based on current age.

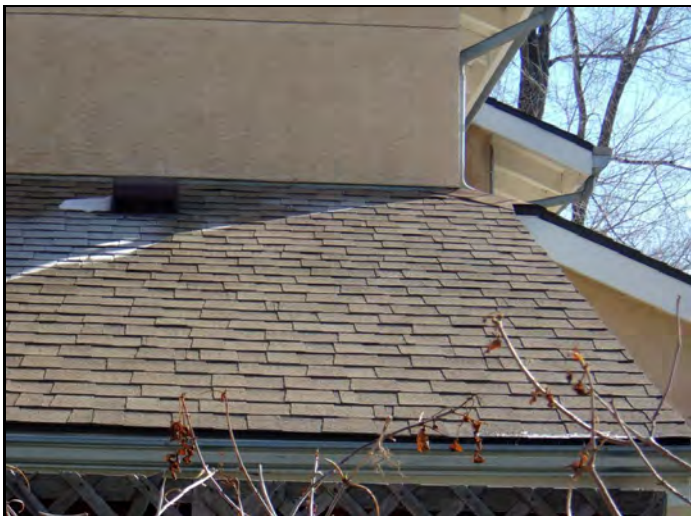
Comp #: 105 Roofs - 2015 - Replace

The roofs are in good condition. We recommend funding to replace this component approximately every 20 - 25 years. Remaining life based on current age.

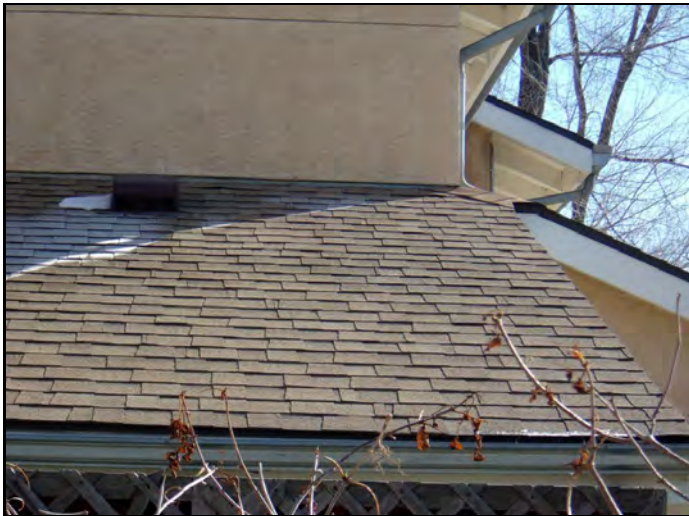
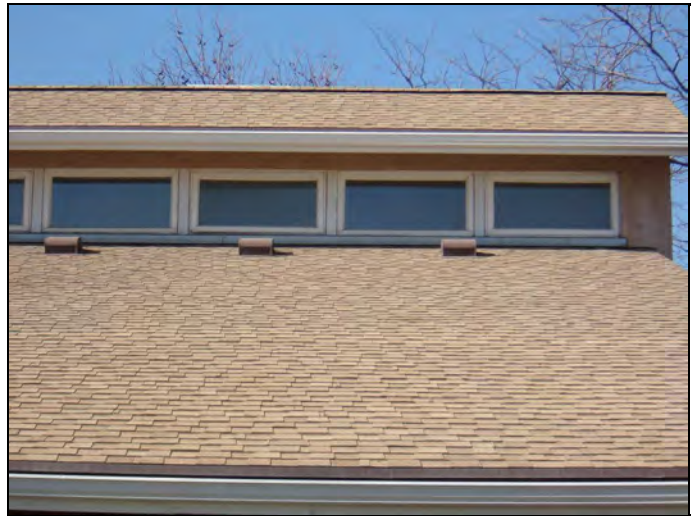
Comp #: 105 Roofs - 2016 - Replace

The roofs are in good condition. We recommend funding to replace this component approximately every 20 - 25 years. Remaining life based on current age.

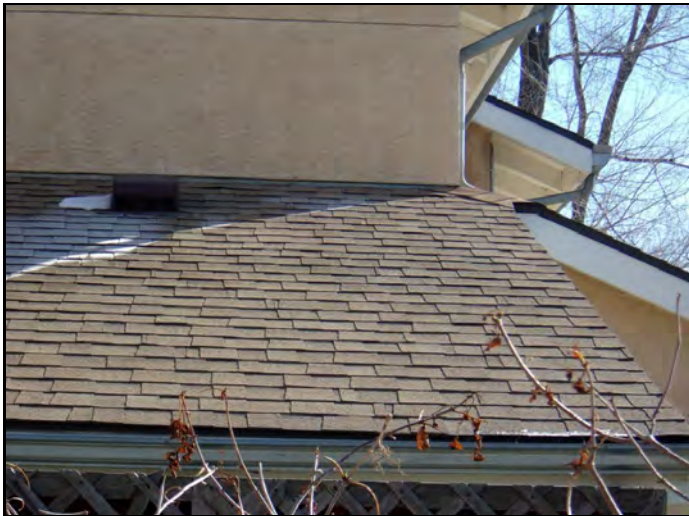
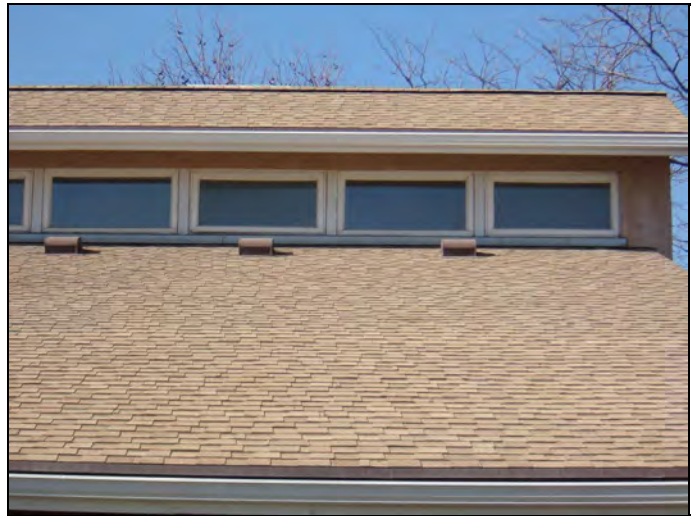
Comp #: 105 Roofs - 2017 - Replace

The roofs are in good condition. We recommend funding to replace this component approximately every 20 - 25 years. Remaining life based on current age.

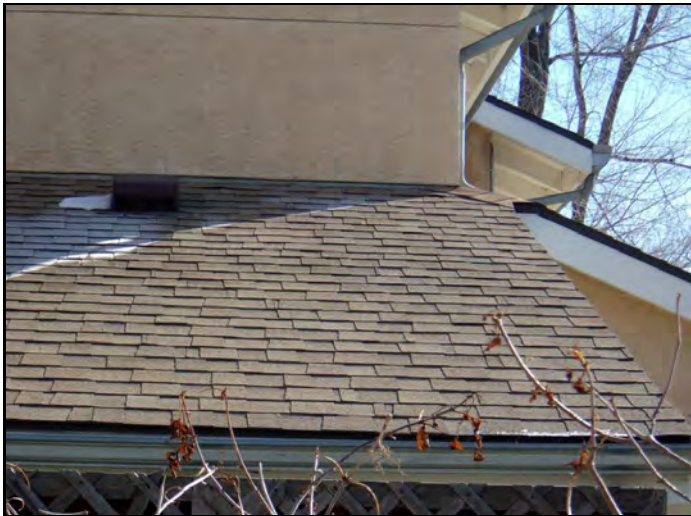
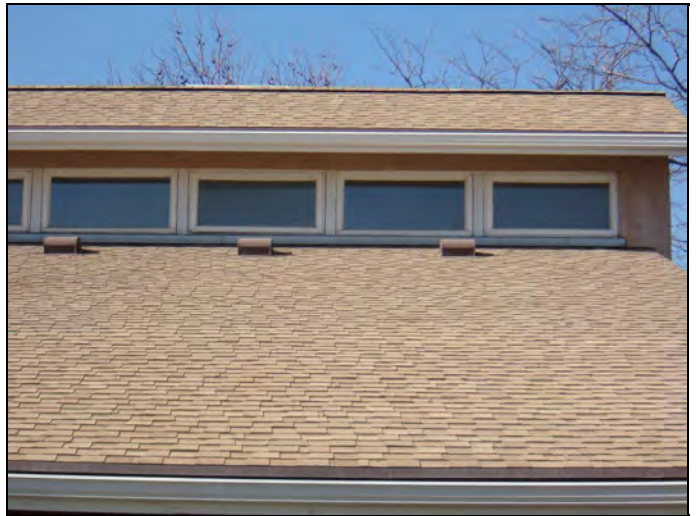
Comp #: 105 Roofs - 2018 - Replace

Research with the client reveals this component will be replaced in 2018. We recommend funding to replace this component approximately every 20 - 25 years. Remaining life based on current age.

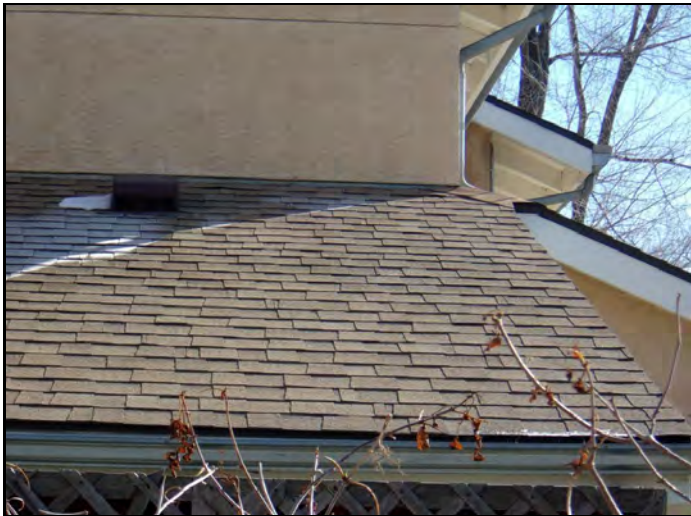
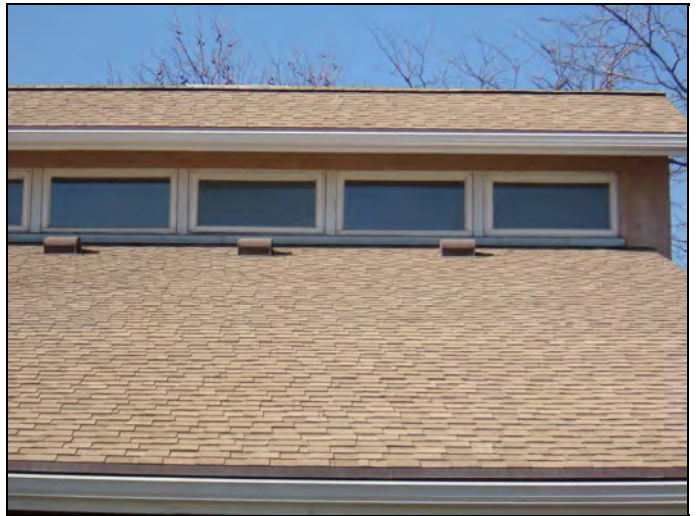
Comp #: 105 Roofs - 2019 - Replace

Research with the client reveals this component will be replaced in 2019. We recommend funding to replace this component approximately every 20 - 25 years. Remaining life based on current age.

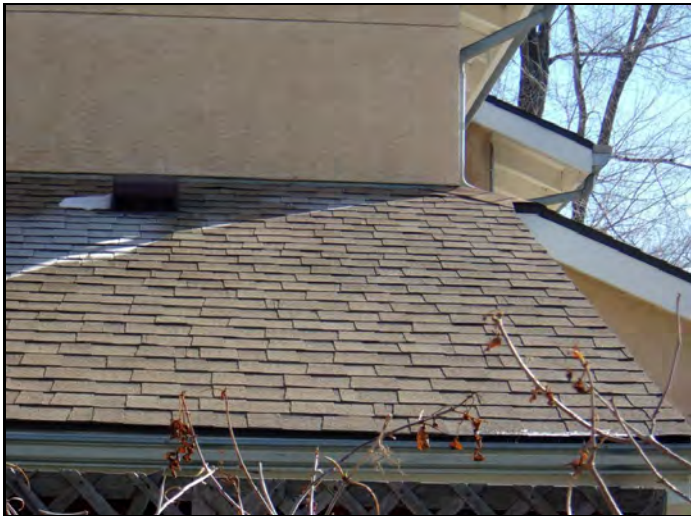
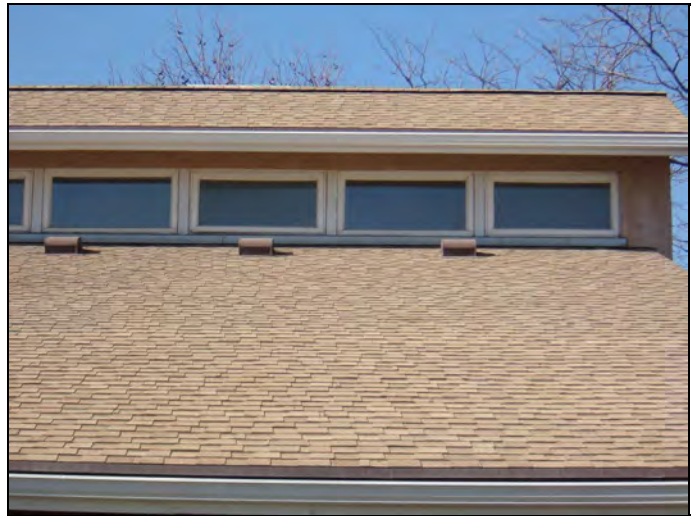
Comp #: 105 Roofs - 2021 - Replace

Research with the client reveals this component will be replaced in 2020. We recommend funding to replace this component approximately every 20 - 25 years. Remaining life based on current age.

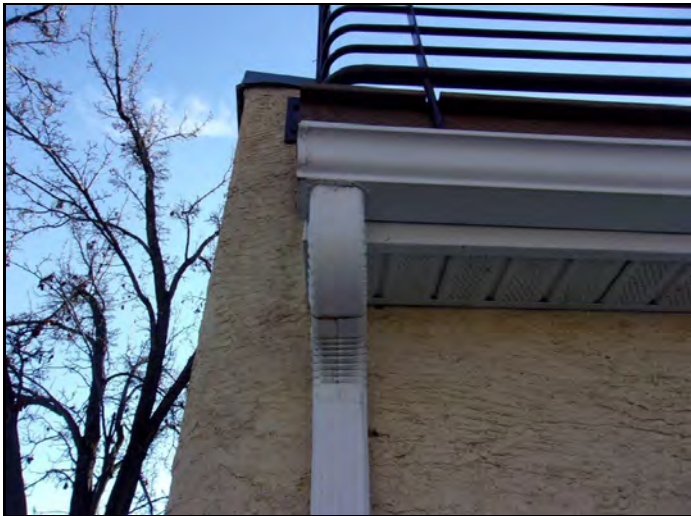
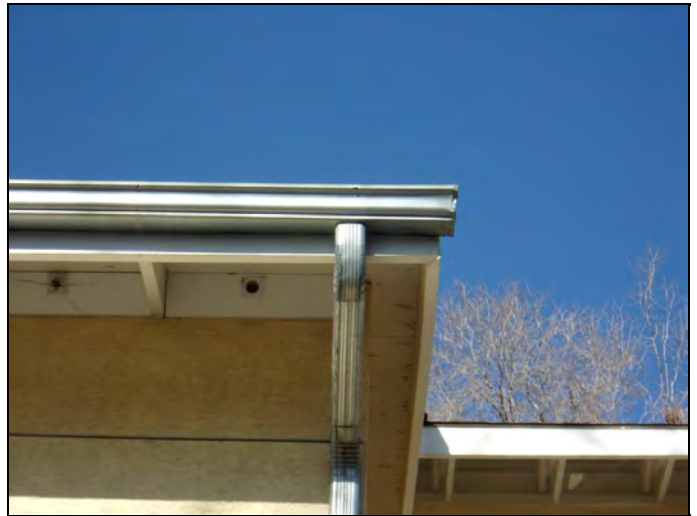
Comp #: 120 Rain Gutters/Downspouts - Replace

Research with the client reveals this component is inspected and replaced yearly.

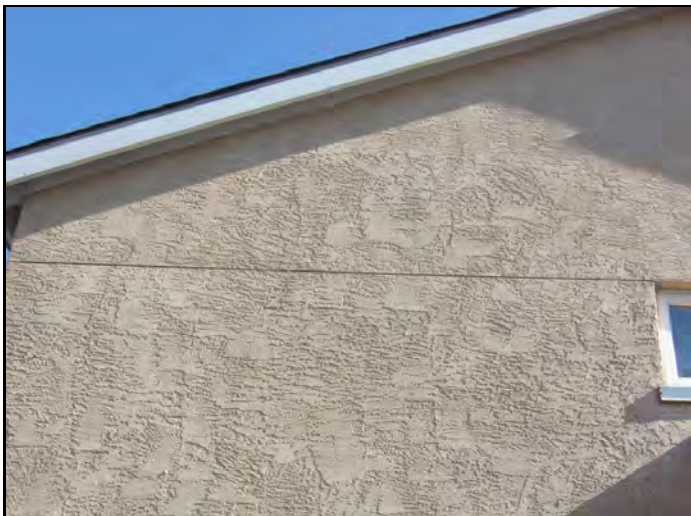
Comp #: 201 Stucco Surfaces - Residential - Repair

The stucco surfaces are in good to fair condition. We recommend funding to repair this component approximately every 12 - 15 years. Remaining life based on current age.

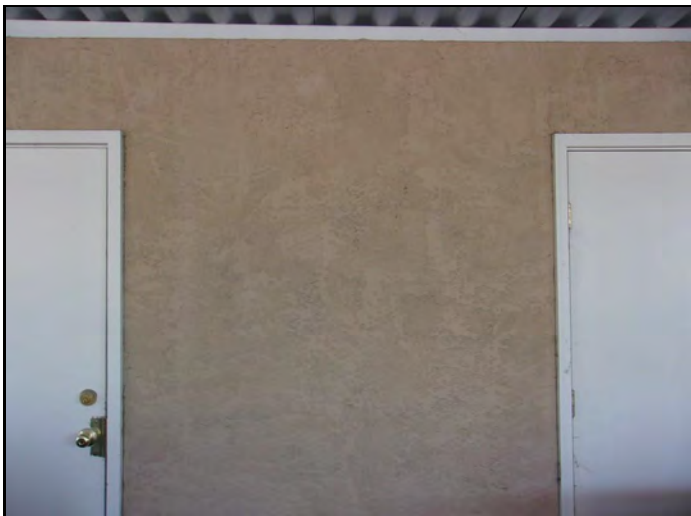
Comp #: 201 Stucco Surfaces - Storage - Repair/Repaint

The stucco surfaces are in good to fair condition. We recommend funding to repair/repaint this component approximately every 12 - 15 years. Remaining life based on current age.

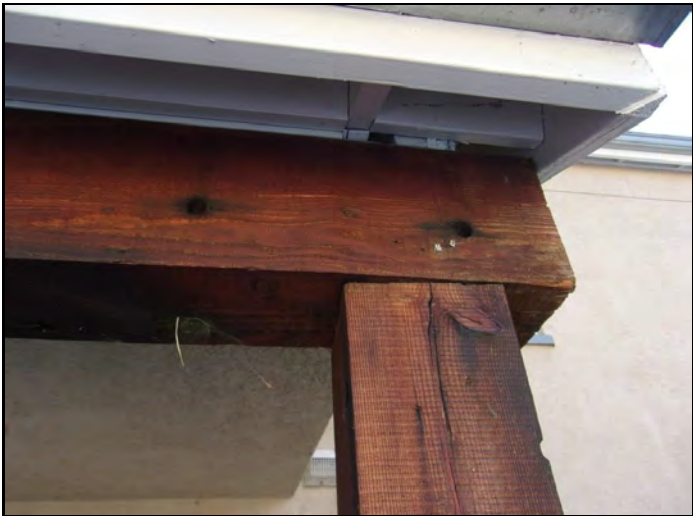
Comp #: 212 Wood Surfaces - Stain

Research with the client reveals this component is stained as necessary as an operating expense.

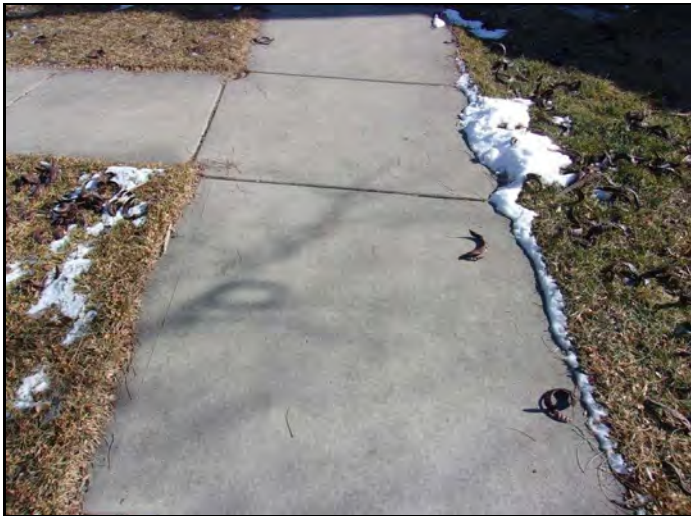
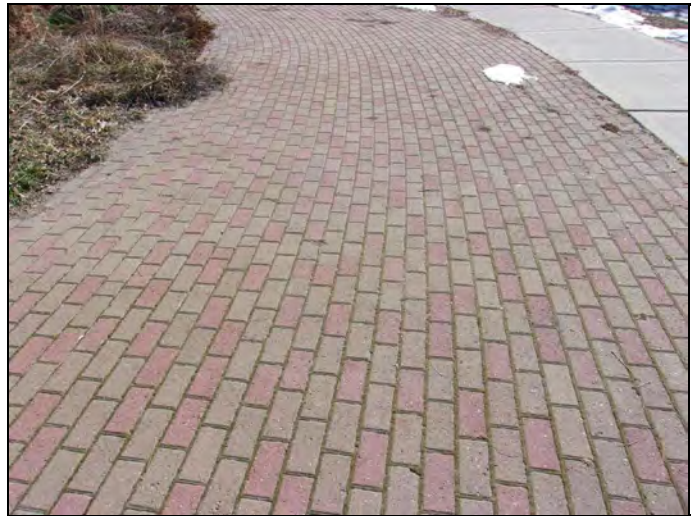
Comp #: 403 Brick & Concrete - Partial Repair/Replace

The brick and concrete are generally in good condition. This component has an extended useful life under normal conditions. We recommend funding to make repairs and partially replace this component approximately every 10 years. Remaining life based on current age.

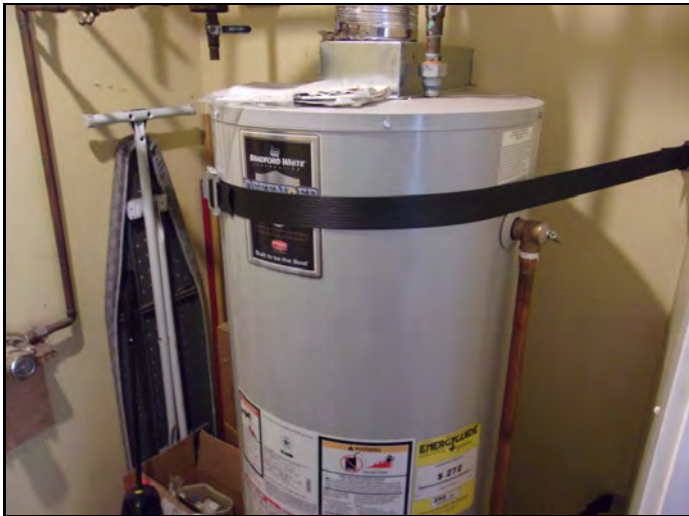
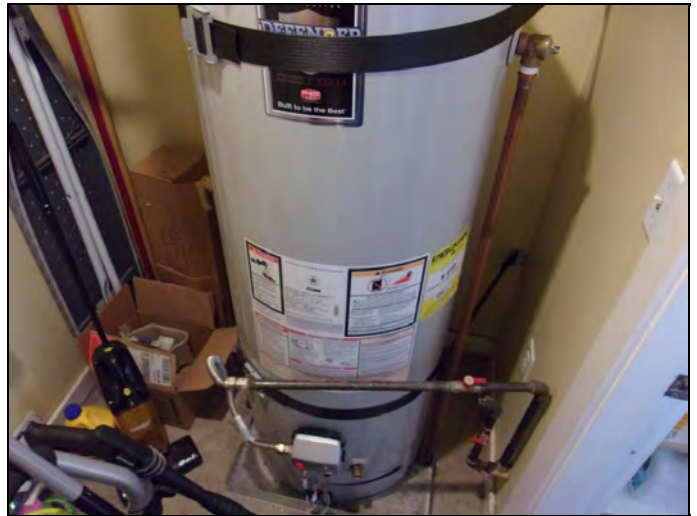
Comp #: 703 Water Heater - Replace

Research with the client reveals this component will not be replaced until 2025. We recommend funding to replace this component approximately every 12 years. Remaining life based on current age.

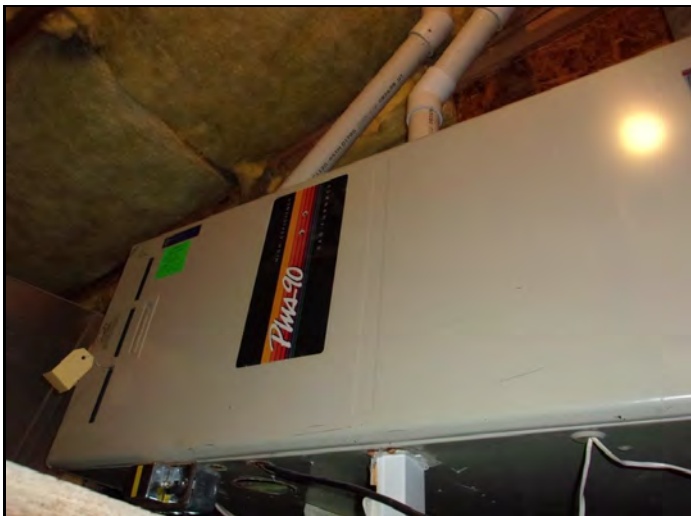
Comp #: 706 Furnaces - 2017 - Replace

The furnace is in working condition. We recommend funding to replace this component approximately every 20 years. Remaining life based on current age.

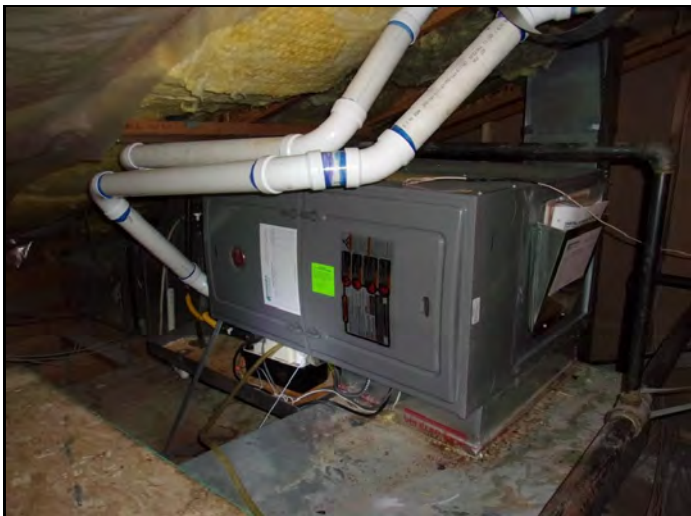
Comp #: 706 Furnaces - Replace

Research with the client reveals this component will not be replaced until 2025. We recommend funding to replace this component approximately every 20 years. Remaining life based on current age.

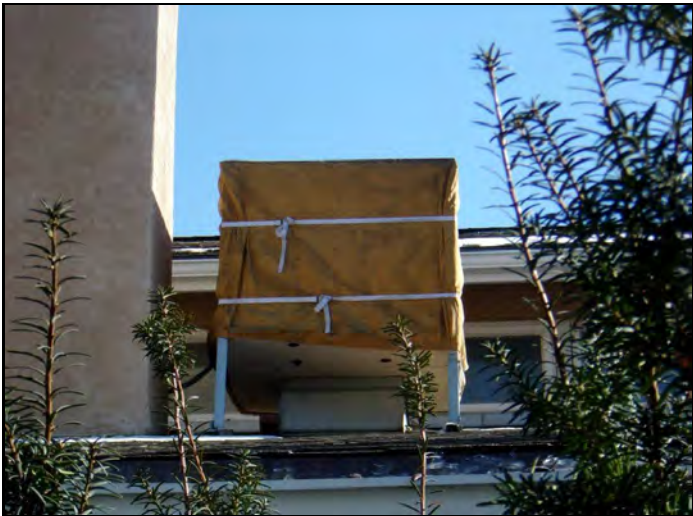
Comp #: 719 Swamp Coolers - Replace

Research with the client reveals this component is being replaced in 2025. We recommend funding to replace this component approximately every 15 - 20 years. Remaining life based on current age.

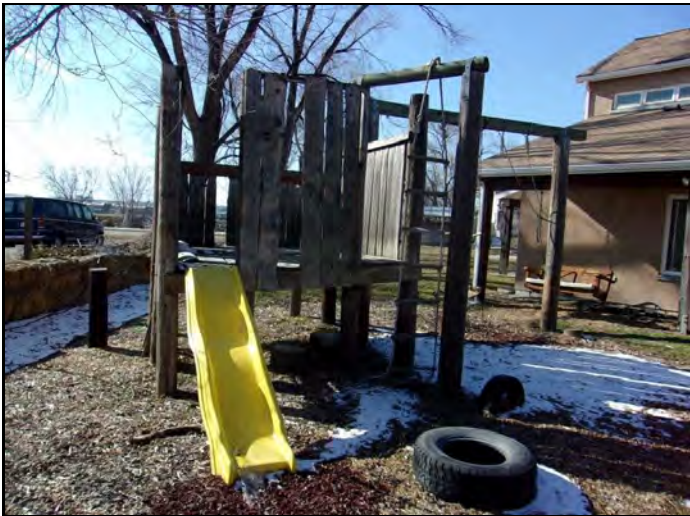
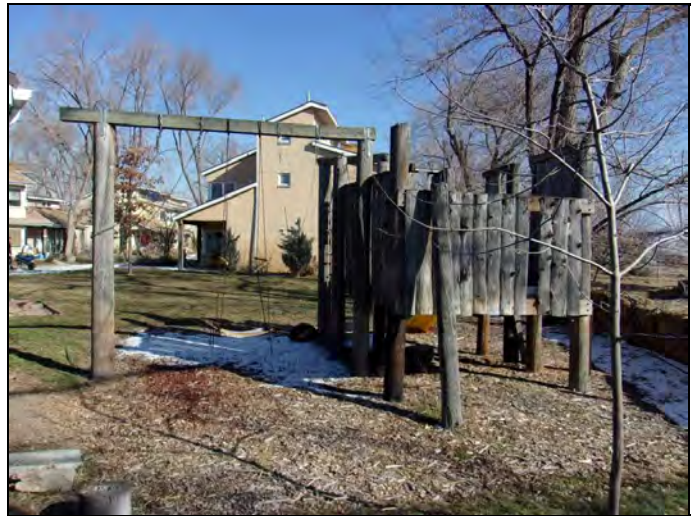
Comp #: 1301 Play Structure - Old - Replace

Research with the client reveals there are no current plans to replace this component.
