Wasatch Commons Condo Association

Level 1 Reserve Study

Report Period – 01/01/2018 – 12/31/2018

Executive Summary – Wasatch Commons Condo Association – ID # 18304

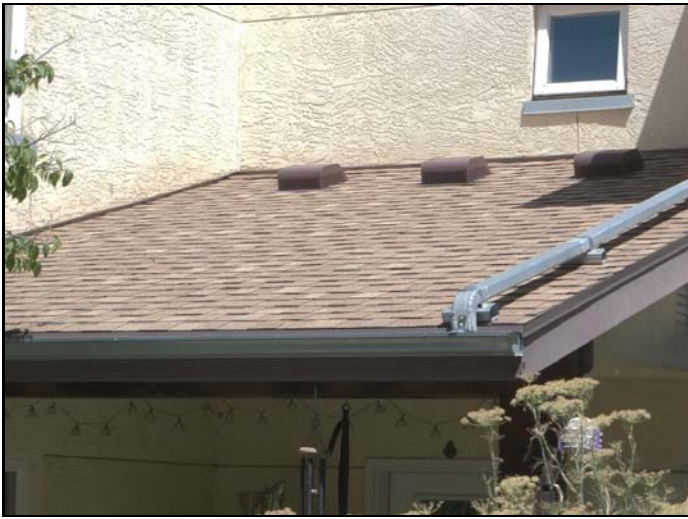
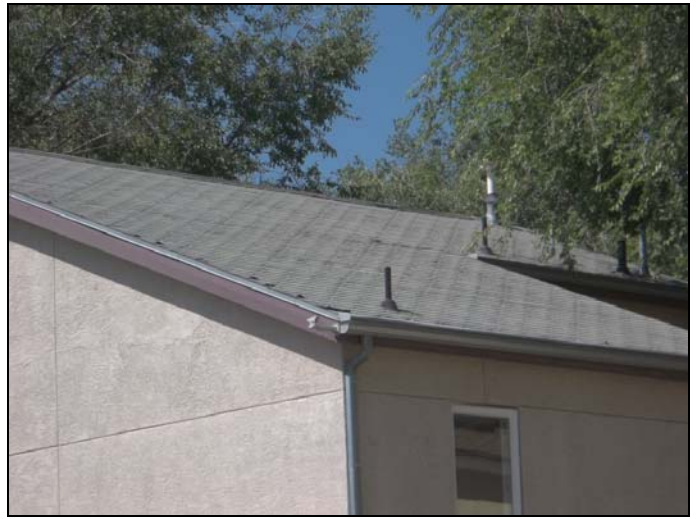
Comp #: 105 Roofs - 2012 - Replace

The roofs are in good condition. We recommend funding to replace this component approximately every 20 - 25 years. Remaining life based on current age.

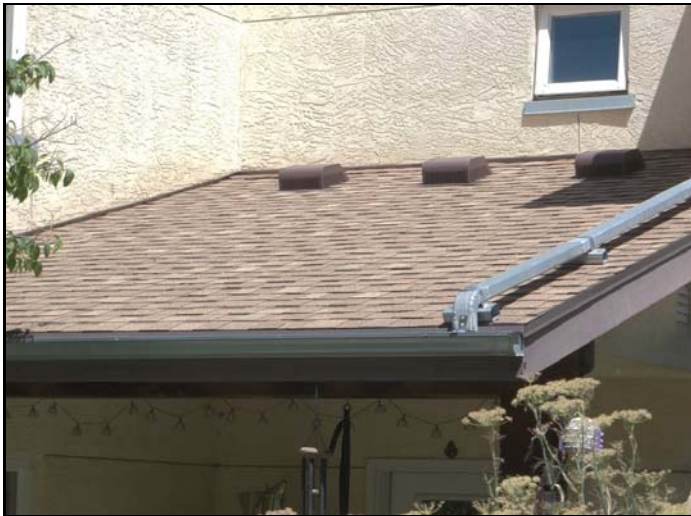
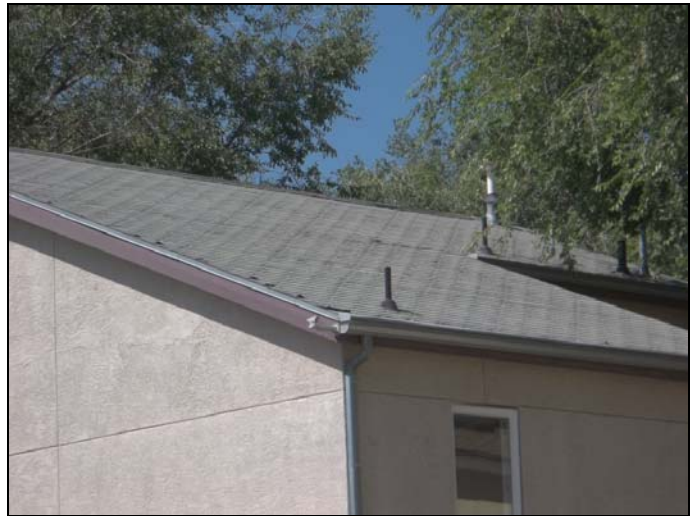
Comp #: 105 Roofs - 2014 - Replace

The roofs are in good condition. We recommend funding to replace this component approximately every 20 - 25 years. Remaining life based on current age.

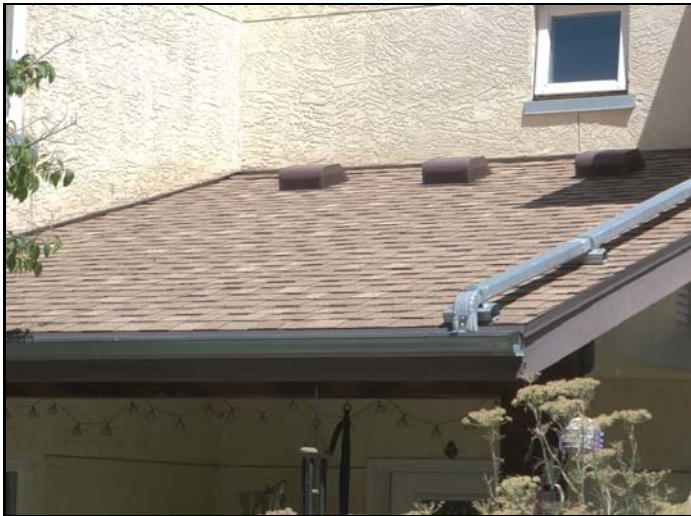
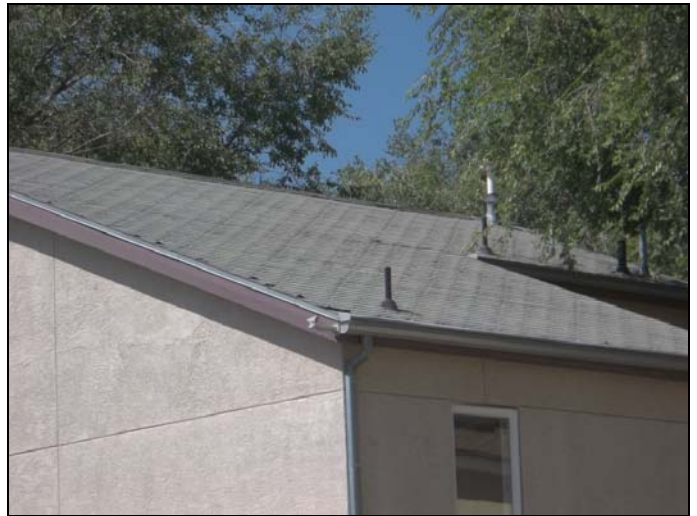
Comp #: 105 Roofs - 2015 - Replace

The roofs are in good condition. We recommend funding to replace this component approximately every 20 - 25 years. Remaining life based on current age.

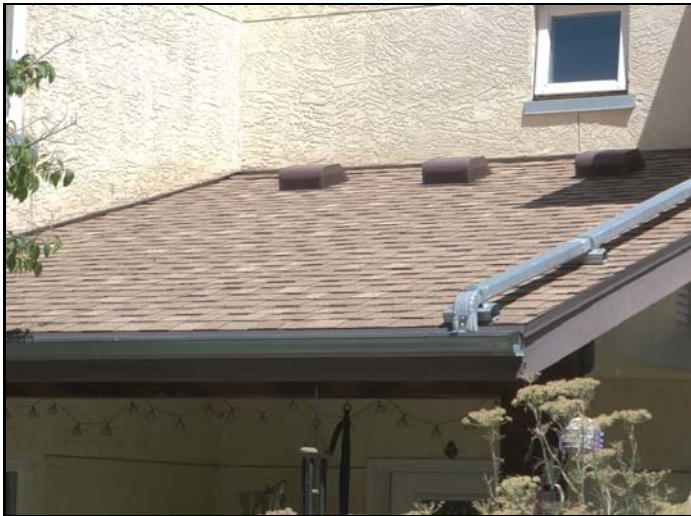
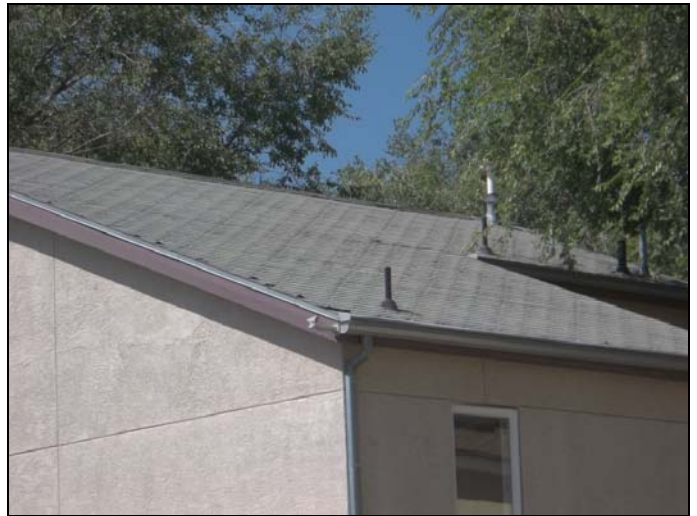
Comp #: 105 Roofs - 2016 - Replace

The roofs are in good condition. We recommend funding to replace this component approximately every 20 - 25 years. Remaining life based on current age.

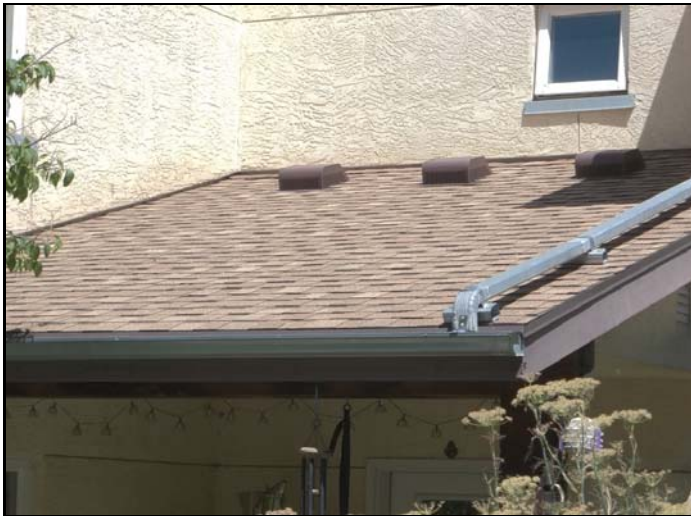
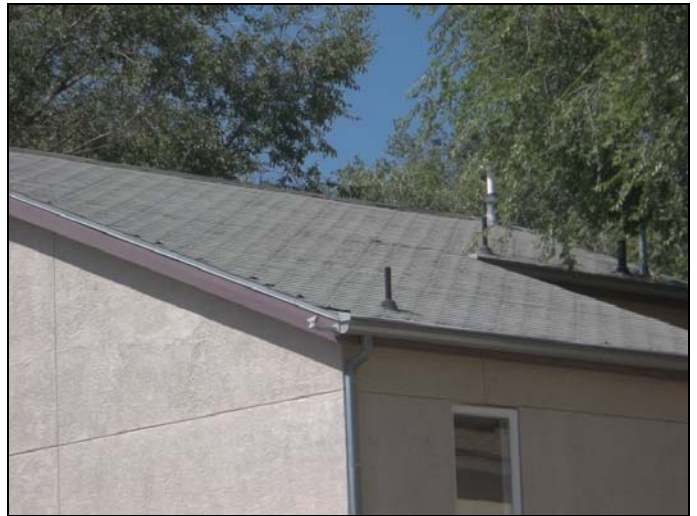
Comp #: 105 Roofs - 2017 - Replace

The roofs are in good condition. We recommend funding to replace this component approximately every 20 - 25 years. Remaining life based on current age.

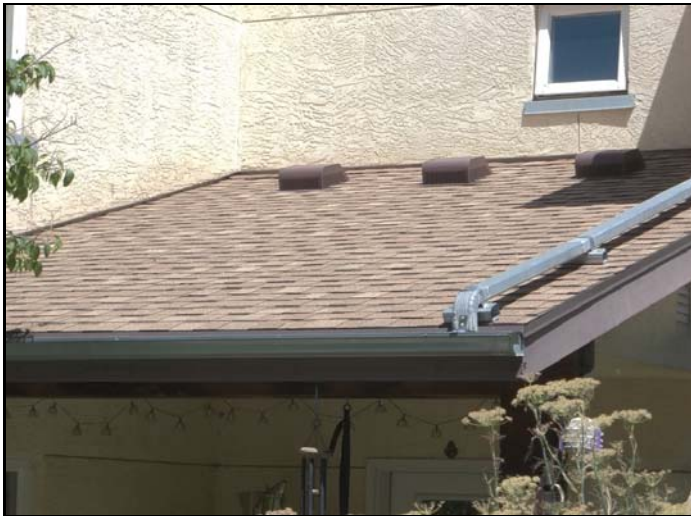
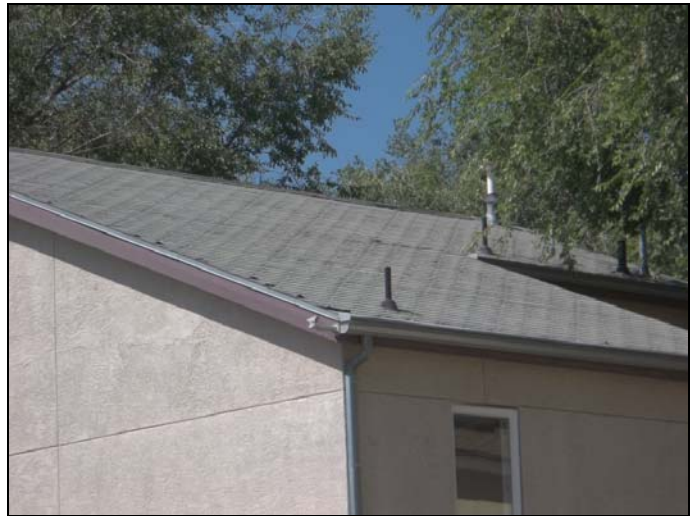
Comp #: 105 Roofs - 2018 - Replace

Research with the client reveals this component will be replaced in 2018. We recommend funding to replace this component approximately every 20 - 25 years. Remaining life based on current age.

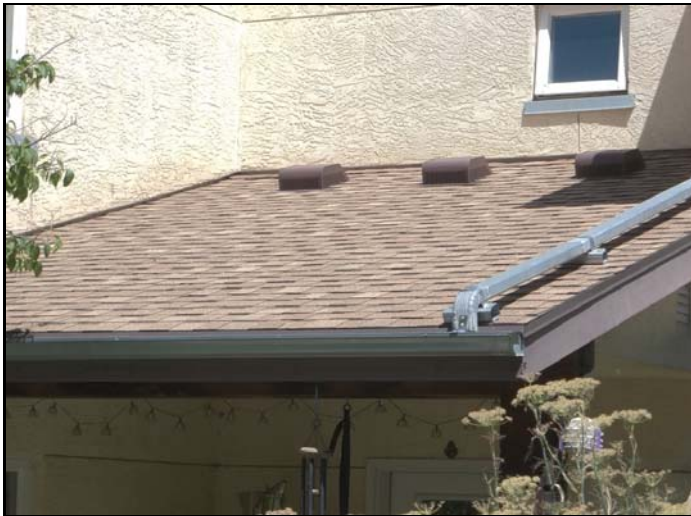
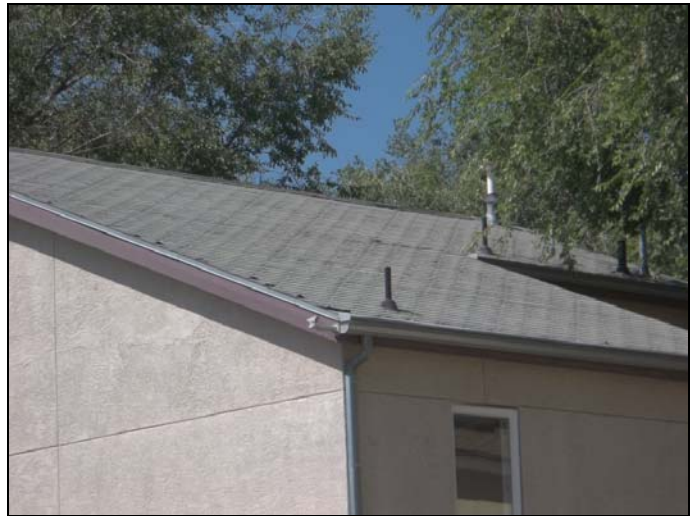
Comp #: 105 Roofs - 2019 - Replace

Research with the client reveals this component will be replaced in 2019. We recommend funding to replace this component approximately every 20 - 25 years. Remaining life based on current age.

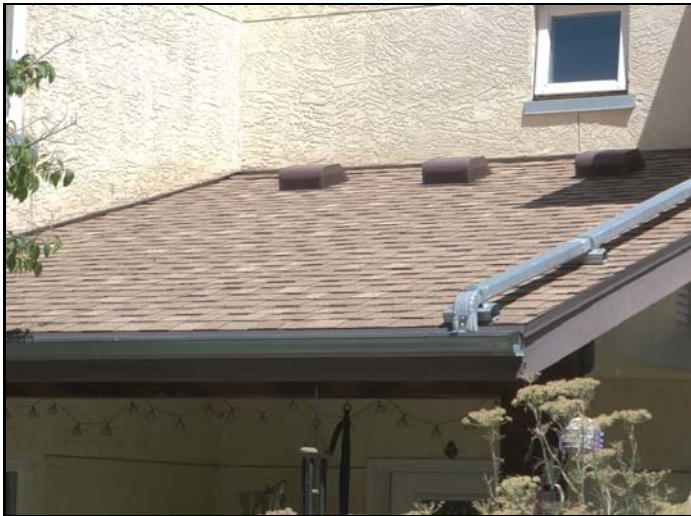
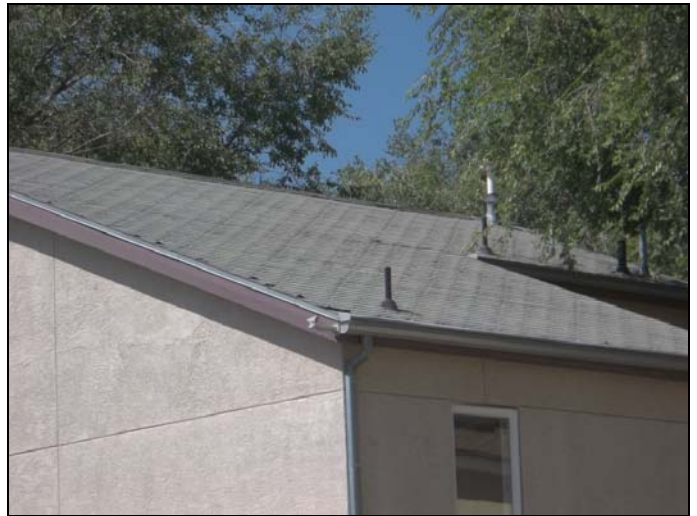
Comp #: 105 Roofs - 2020 - Replace

Research with the client reveals this component will be replaced in 2020. We recommend funding to replace this component approximately every 20 - 25 years. Remaining life based on current age.

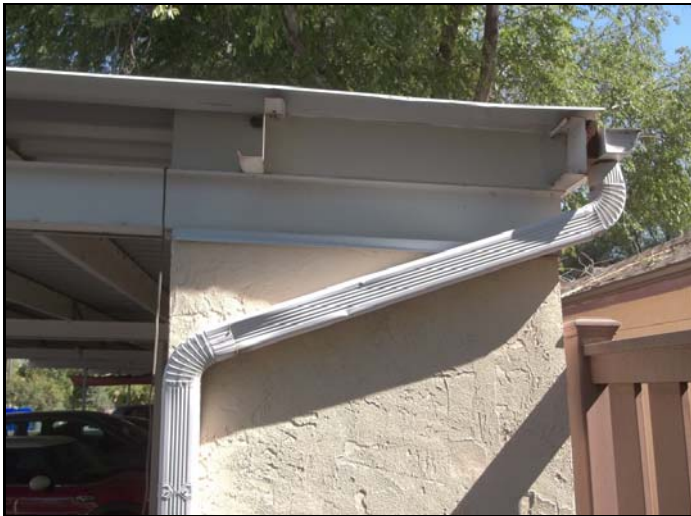
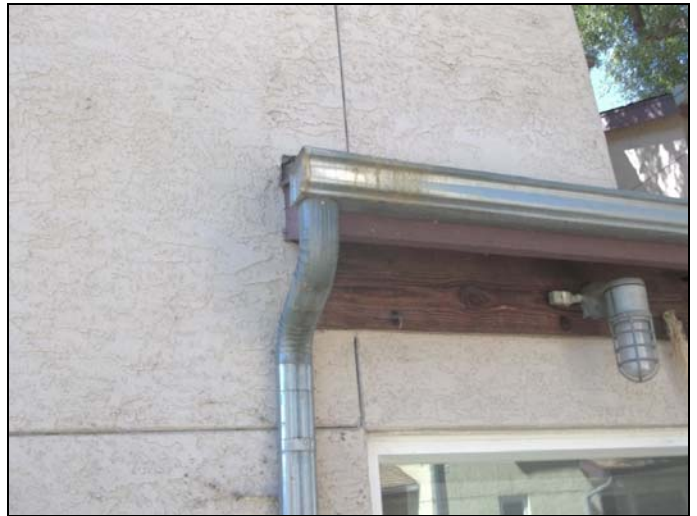
Comp #: 120 Rain Gutters/Downspouts - Replace

Research with the client reveals this component is inspected and replaced yearly.

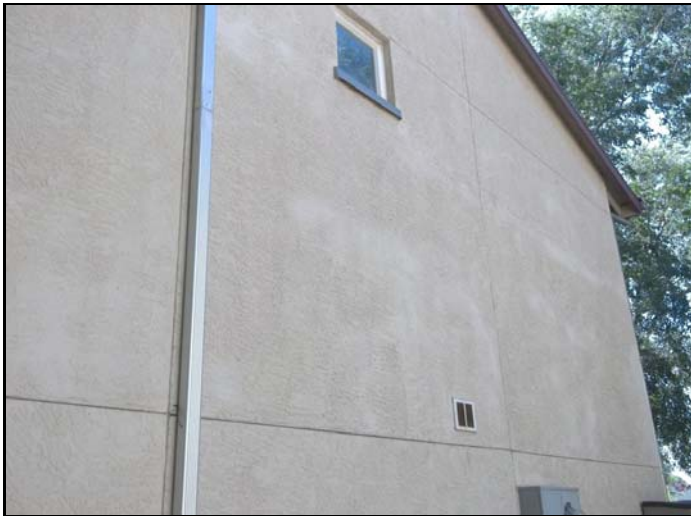
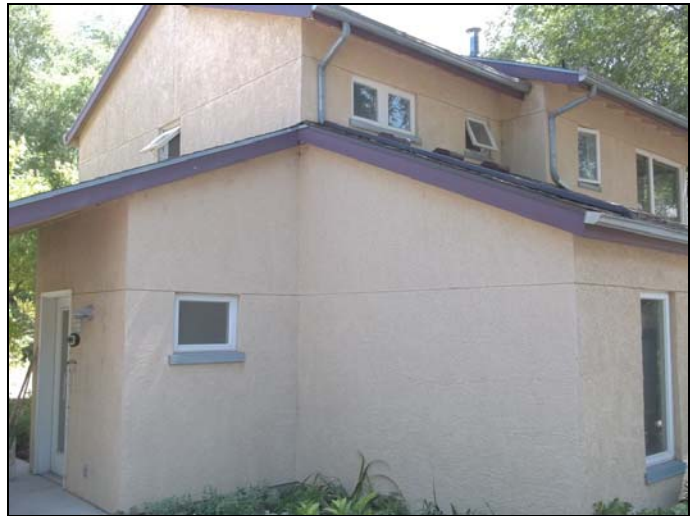
Comp #: 201 Stucco Surfaces - Residential - Repair

The stucco surfaces are in good condition. We recommend funding to an allowance to repair this component approximately every 10 years. Remaining life based on current age.

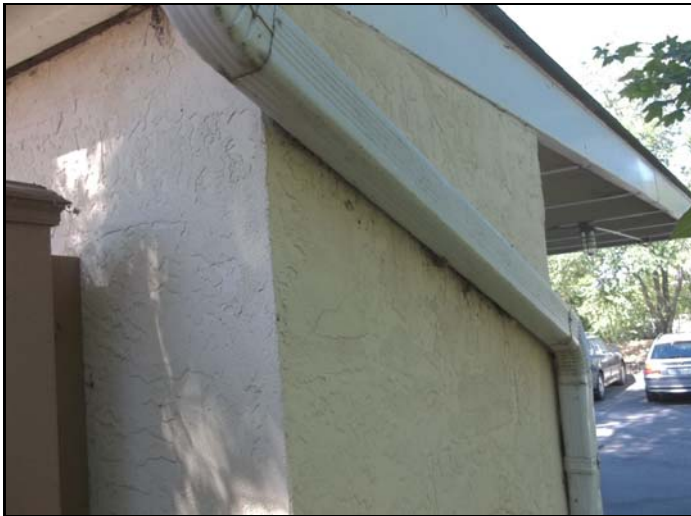
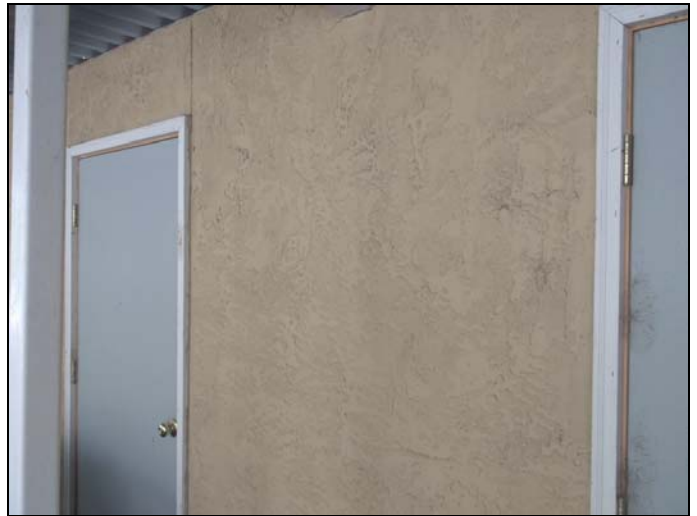
Comp #: 201 Stucco Surfaces - Storage - Repair/Repaint

The stucco surfaces are in good to fair condition. We recommend funding to repair/repaint this component approximately every 12 - 15 years to protect the stucco surface and maintain appearance. Remaining life based on current condition.

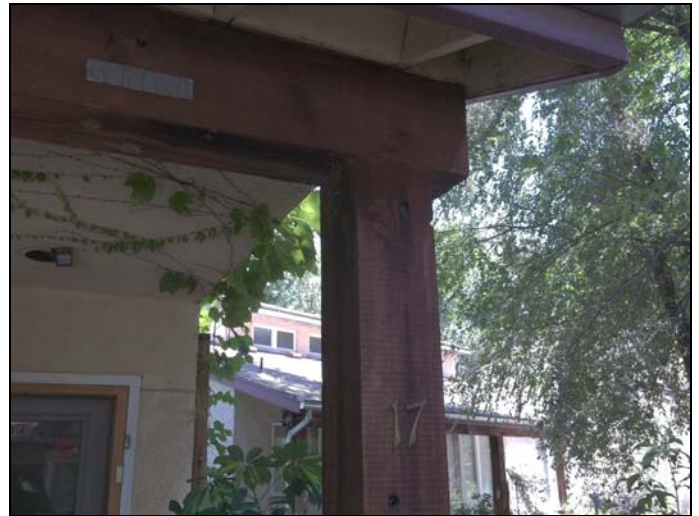
Comp #: 212 Wood Surfaces - Stain

The stained wood surfaces are in poor condition. We recommend funding to stain this component approximately every 4 - 6 years to maintain appearance and protect wood surfaces. Remaining life based on current condition.

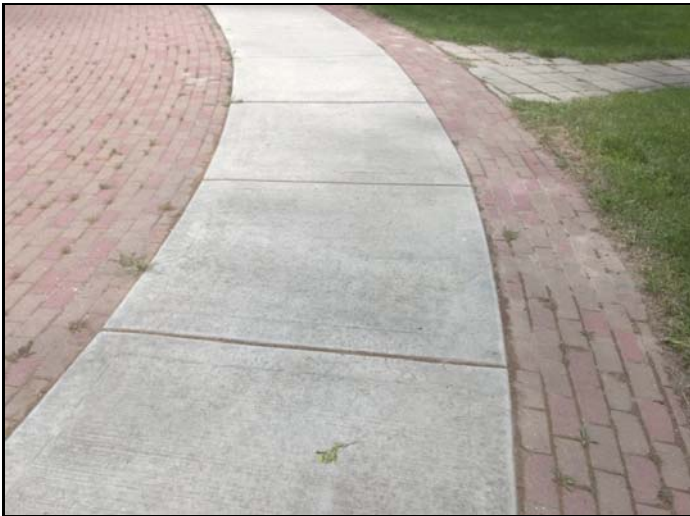
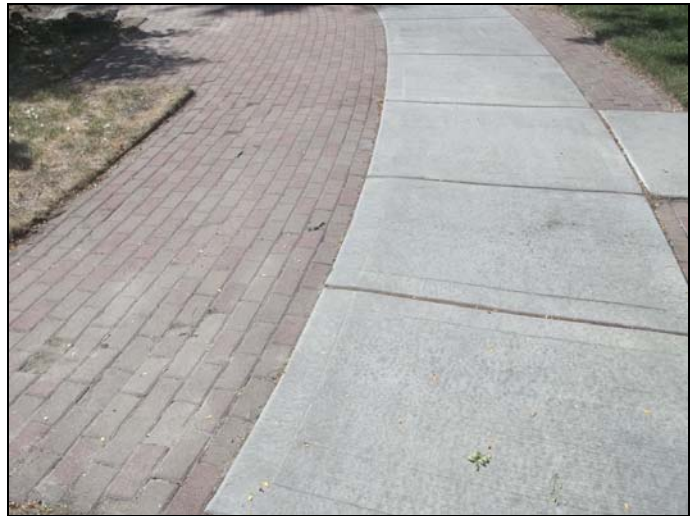
Comp #: 403 Brick & Concrete - Repair/Replace

The brick and concrete are generally in good condition. This component has an extended useful life under normal conditions. We recommend funding to make repairs and partially replace this component approximately every 10 years. Remaining life based on current age.

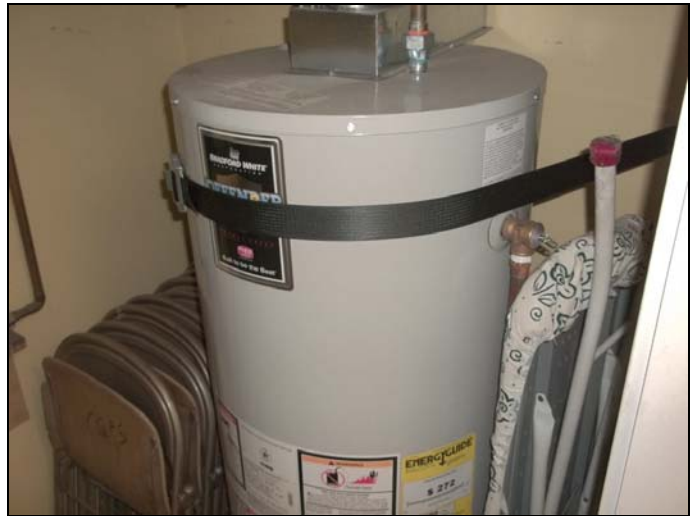
Comp #: 703 Water Heater - Replace

The water heater is in working condition. We recommend funding to replace this component approximately every 12 - 15 years. Remaining life based on current age.

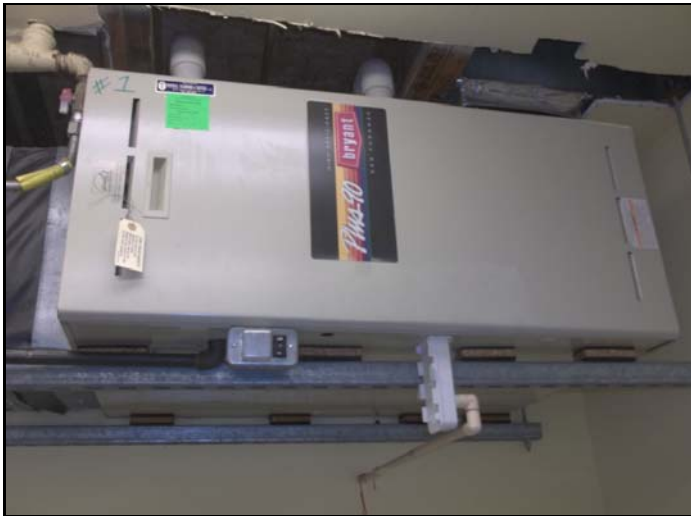
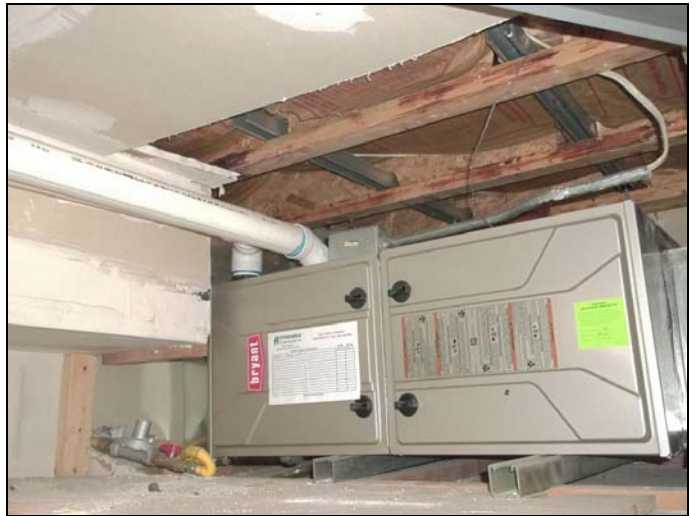
Comp #: 706 Furnaces - 2017 - Replace

The furnace is in working condition. We recommend funding to replace this component approximately every 20 years. Remaining life based on current age.

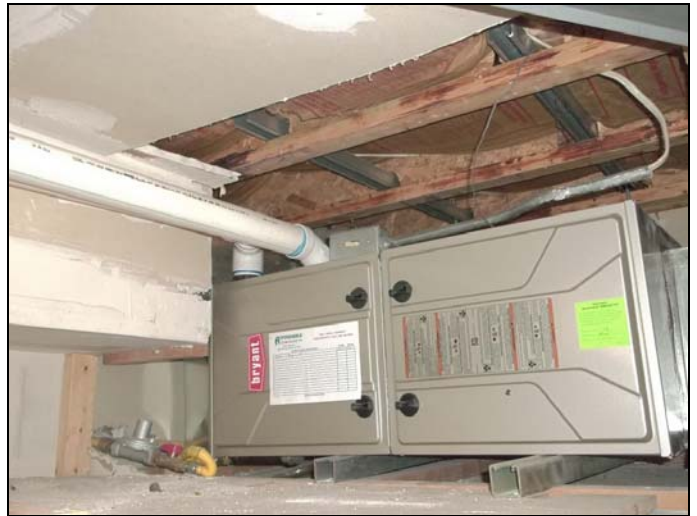
Comp #: 706 Furnaces - Replace

The furnaces are in working condition. We recommend funding to replace this component approximately every 20 years. Remaining life based on current condition.
