Wasatch Commons Condo Association

Level 2 Reserve Study

Report Period – 01/01/2023 – 12/31/2023

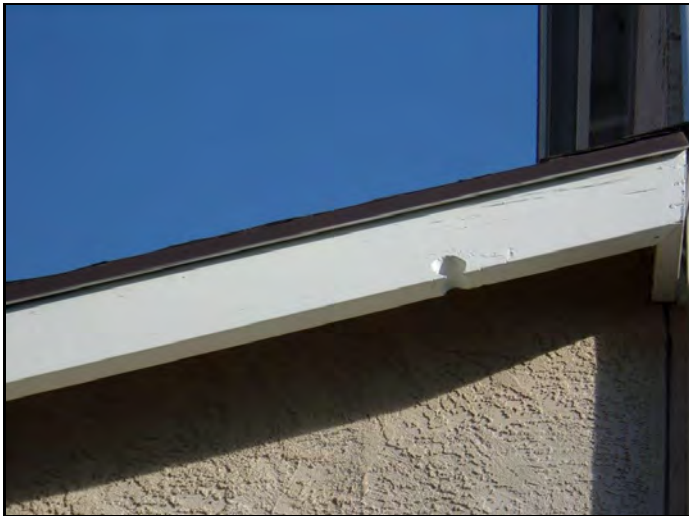
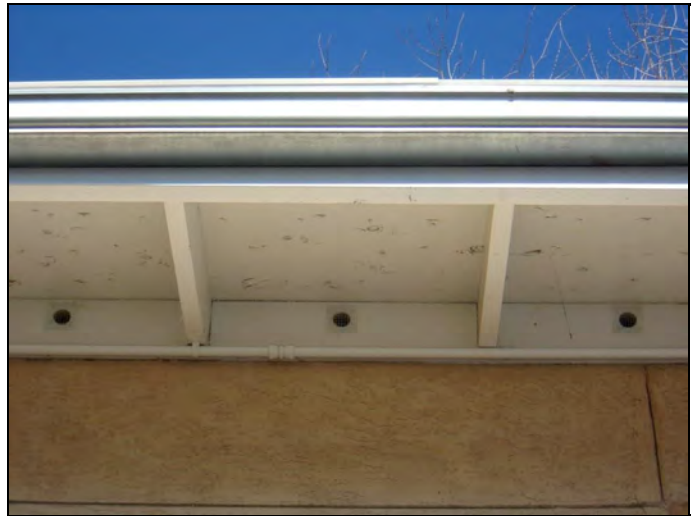
Comp #: 202 Wood Trim - 2020 - Repaint

Location: **Building Exteriors**

Quantity: **(26) Units**

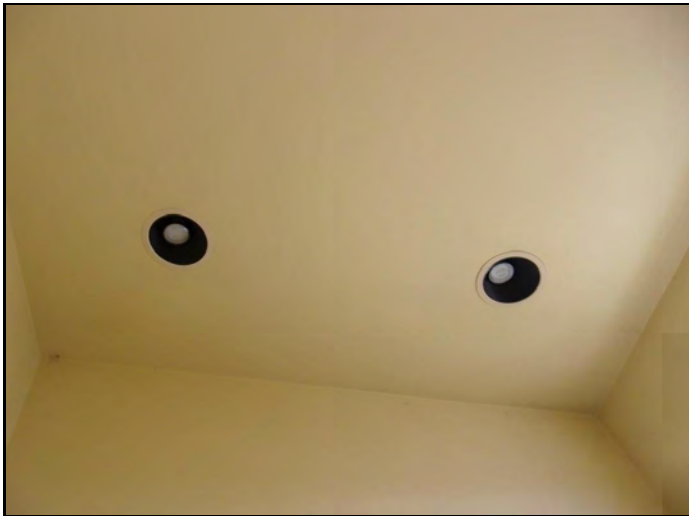
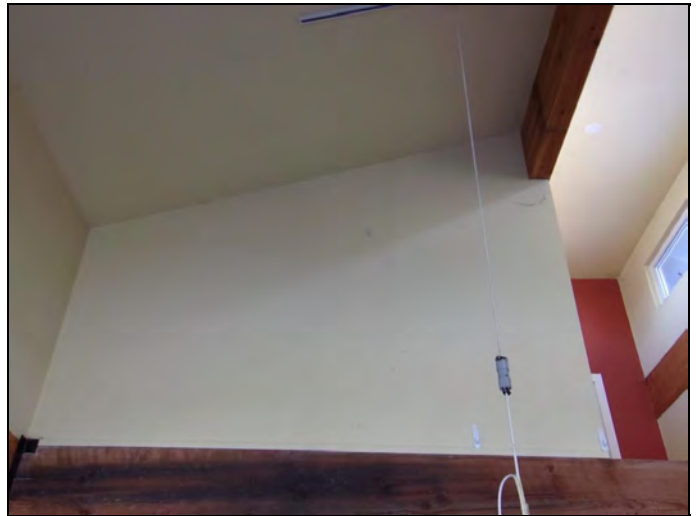
Comp #: 216 Interior Surfaces - Repaint

Location: Clubhouse & Shop Interiors

Quantity: (2) Buildings

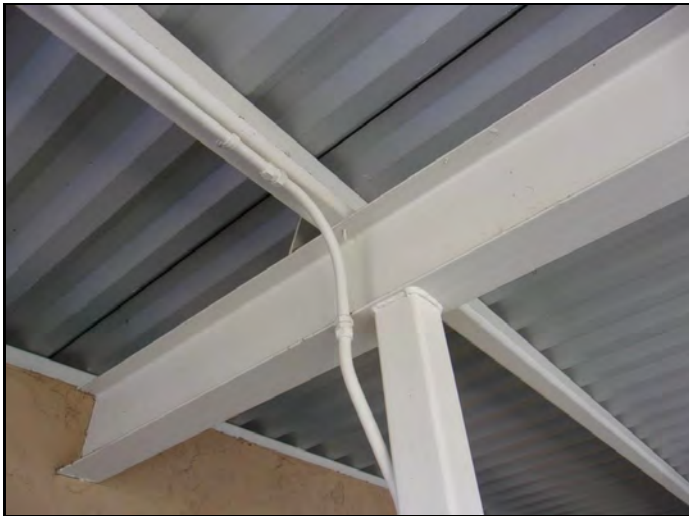
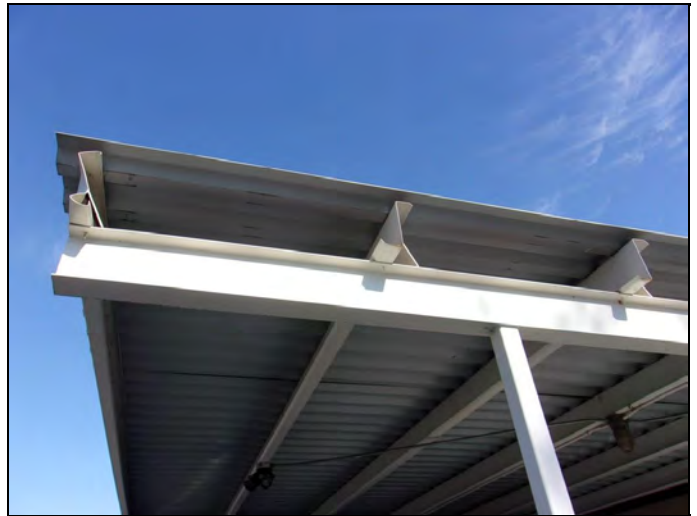
Comp #: 223 Carports - Repaint

Location: **Parking Lots**

Quantity: **(3) Carports**

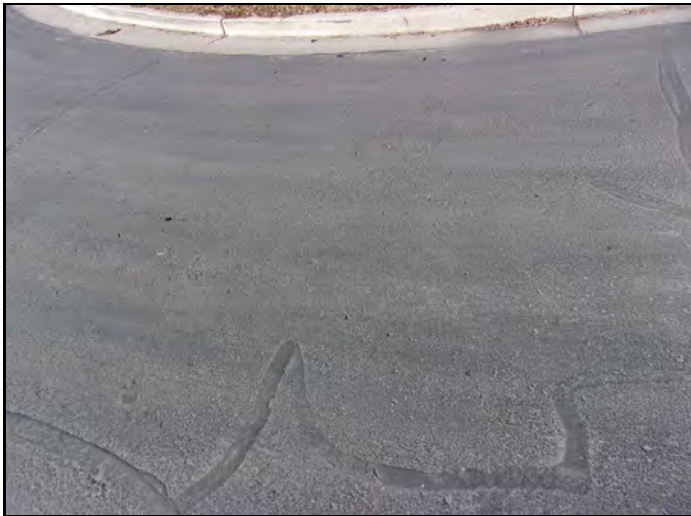
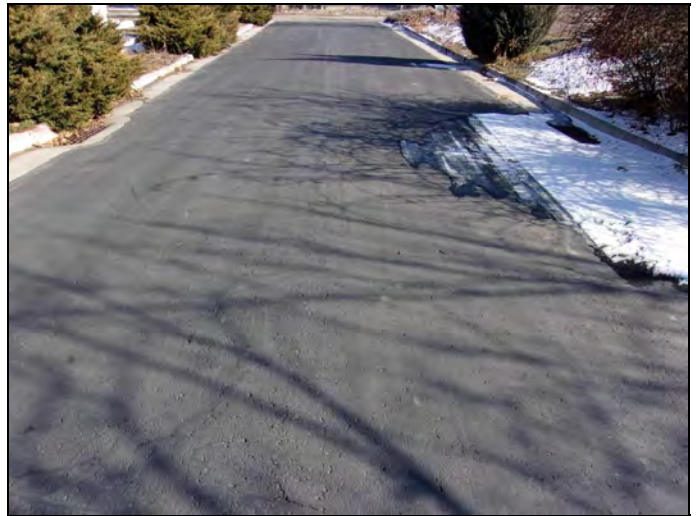
Comp #: 401 Asphalt - Major Rehab

Location: **Community Parking & Streets**

Quantity: **Approx 21,000 Sq.ft.**

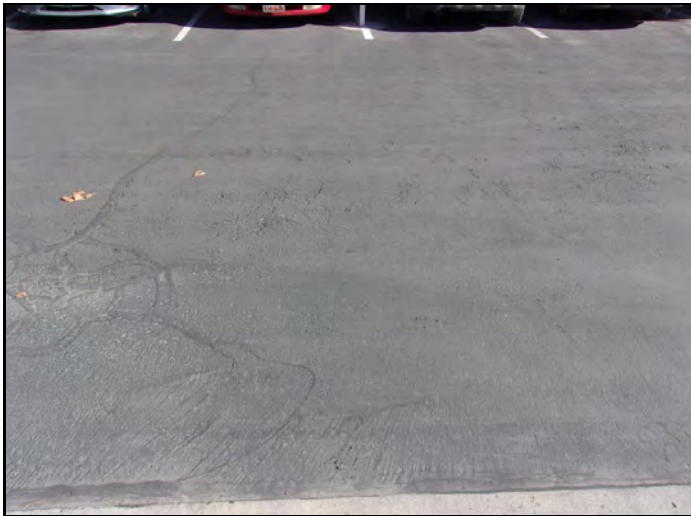
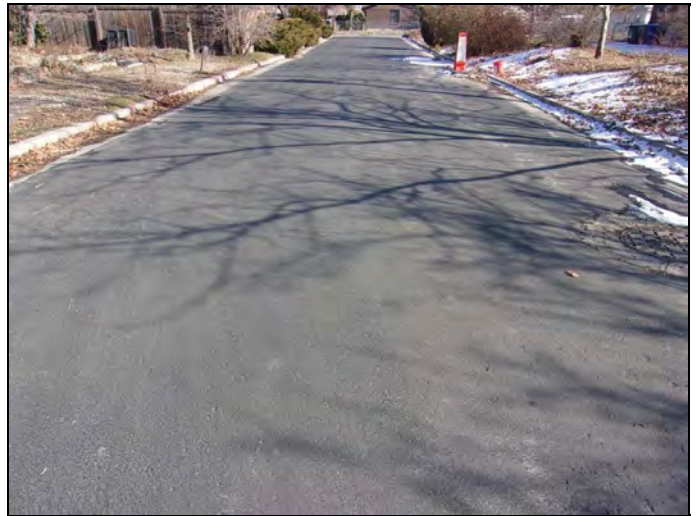
Comp #: 402 Asphalt - Seal Coat

Location: **Community Parking & Streets**

Quantity: **Approx 21,000 Sq.ft.**

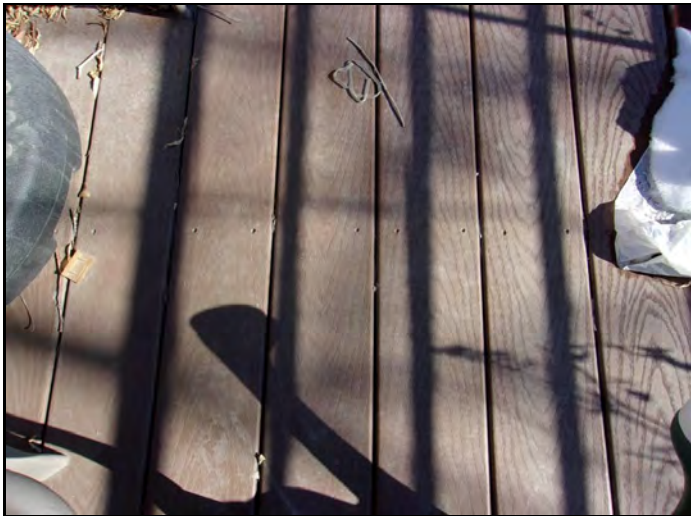
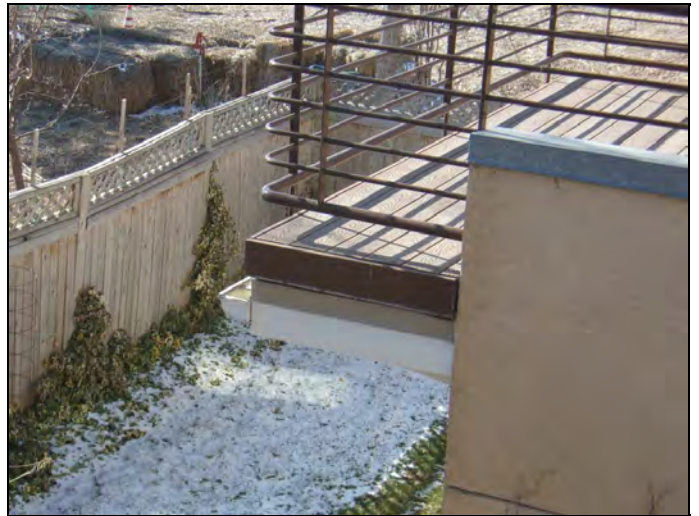
Comp #: 609 Decking - Replace

Location: **Unit Decks**

Quantity: **Multiple Decks**

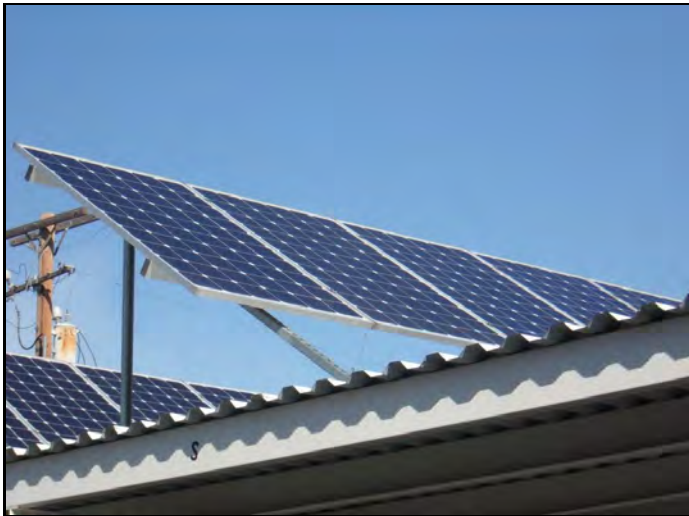
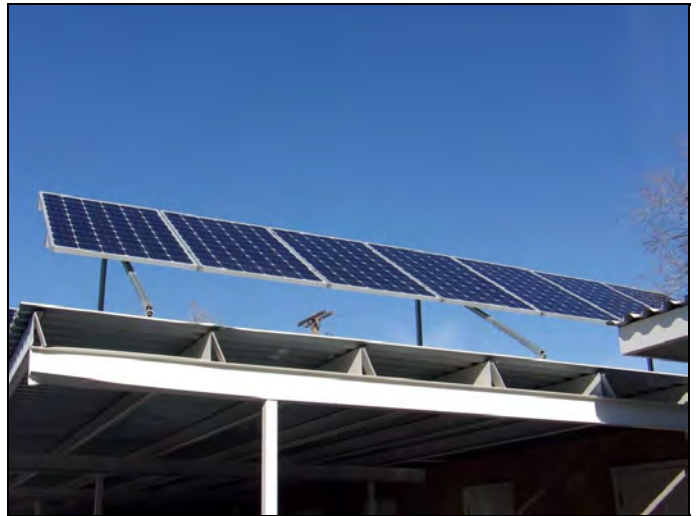
Comp #: 790 Solar Panels - East - Replace

Location: **Carport Roofs**

Quantity: **(1) System**

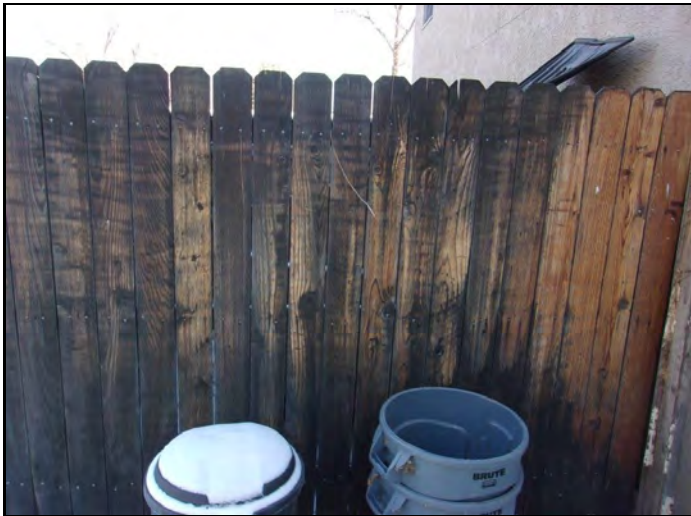
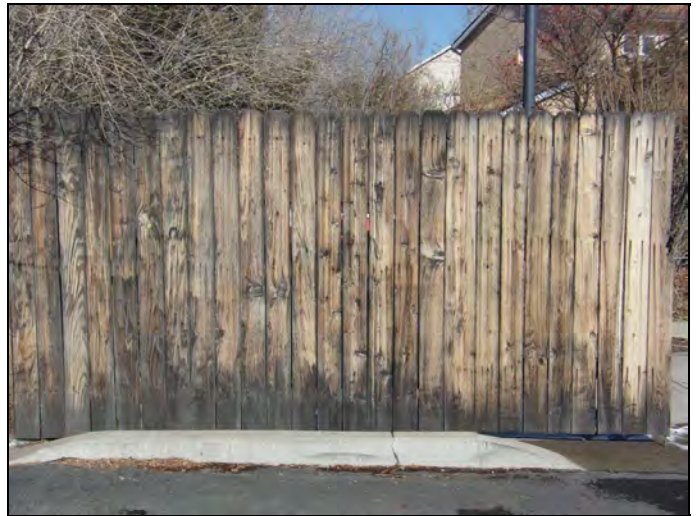
Comp #: 1001 Dumpster Enclosures - Replace

Location: **Dumpster Enclosures**

Quantity: **(2) Enclosures**

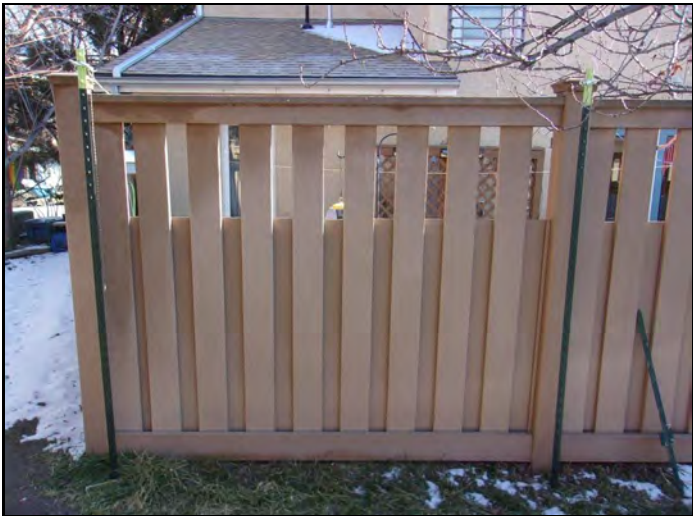
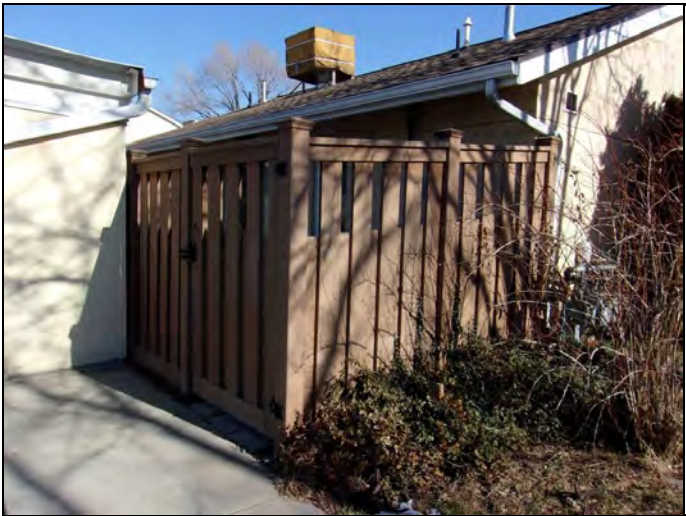
Comp #: 1008 Composite Fencing - Replace

Location: **Common Area**

Quantity: **Approx 85 Linear ft.**

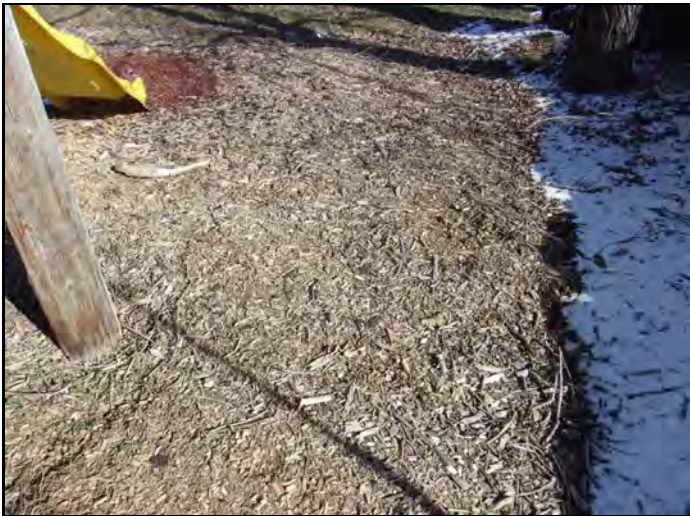
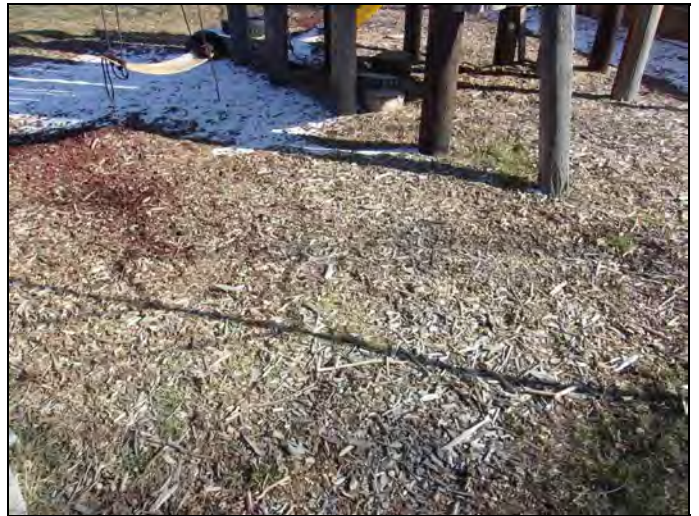
Comp #: 1303 Play Area Groundcover - Refill

Location: **Play Area**

Quantity: **Approx 500 Sq.ft.**

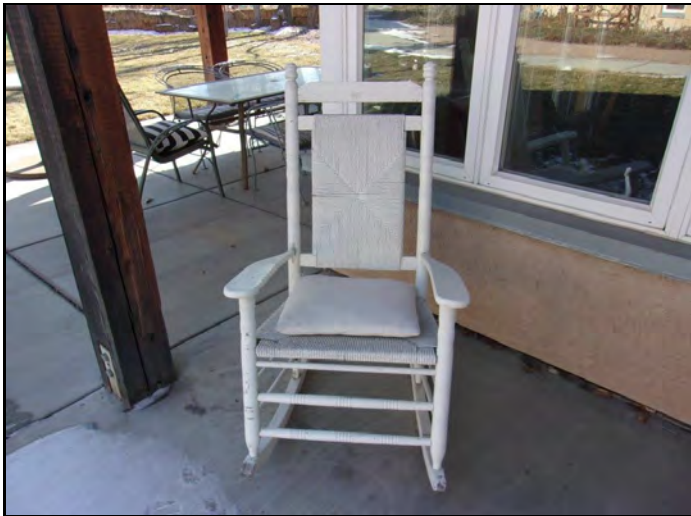
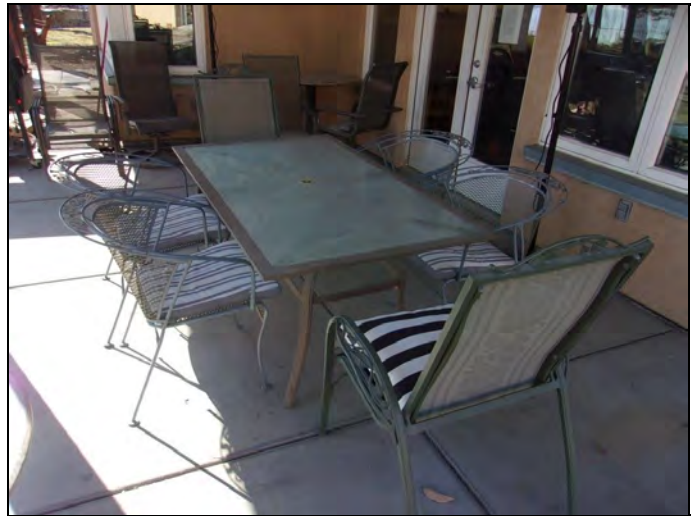
Comp #: 1390 Patio Furniture - Replace

Location: **Clubhouse Exterior**

Quantity: **Assorted Pieces**

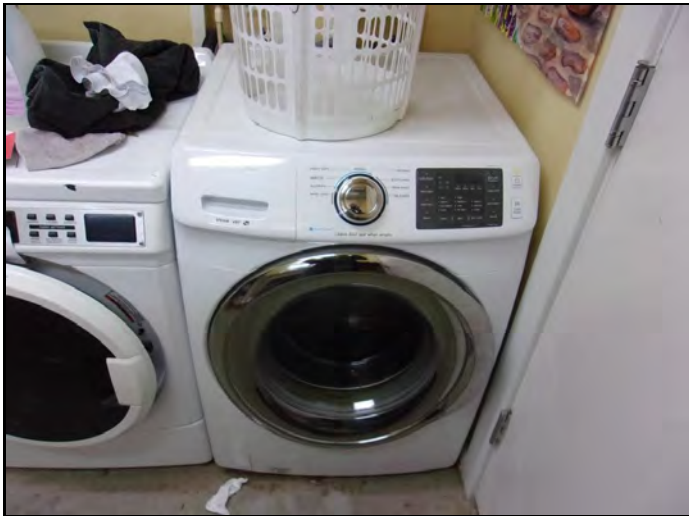
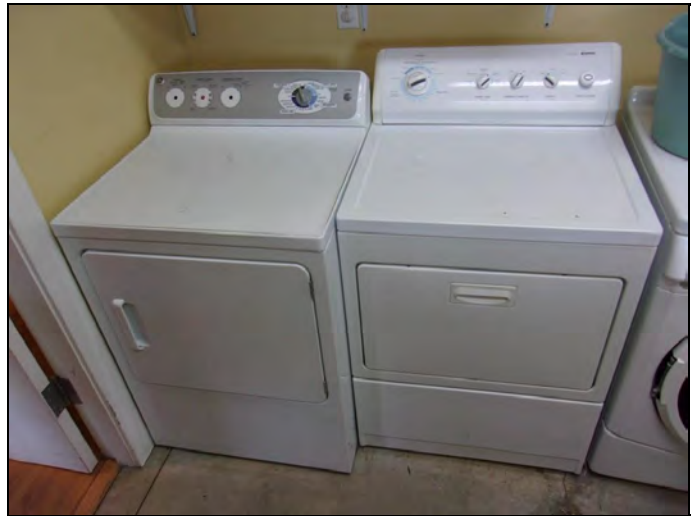
Comp #: 1401 Laundry Equipment - 2010 - Replace

Location: Clubhouse Interior

Quantity: (1) Dryer

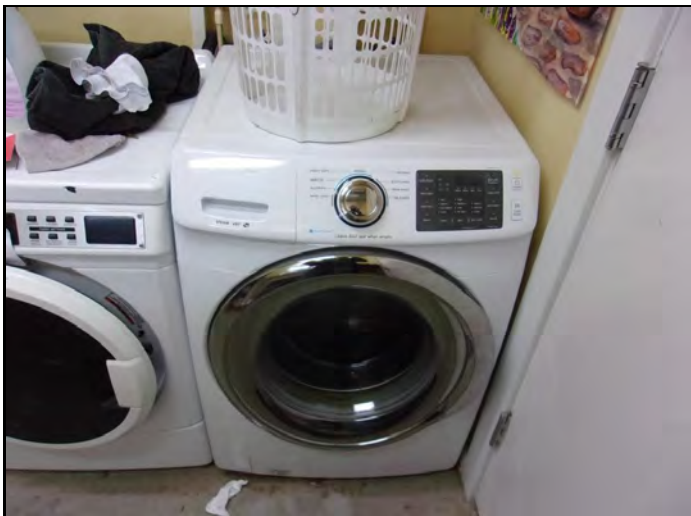
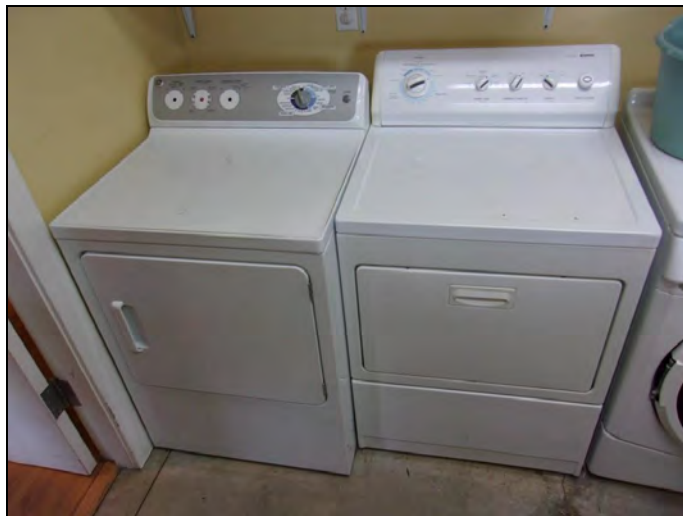
Comp #: 1401 Laundry Equipment - 2017 - Replace

The laundry equipment is in working condition. We recommend replacing this component approximately every 10 - 15 years. Remaining life based on current age.

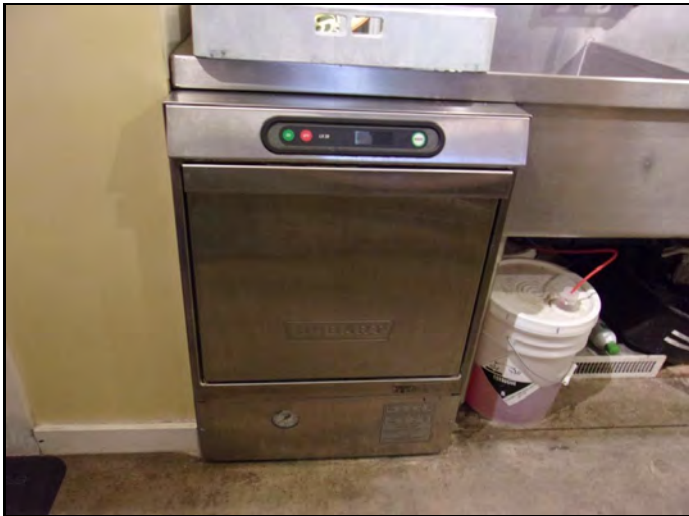
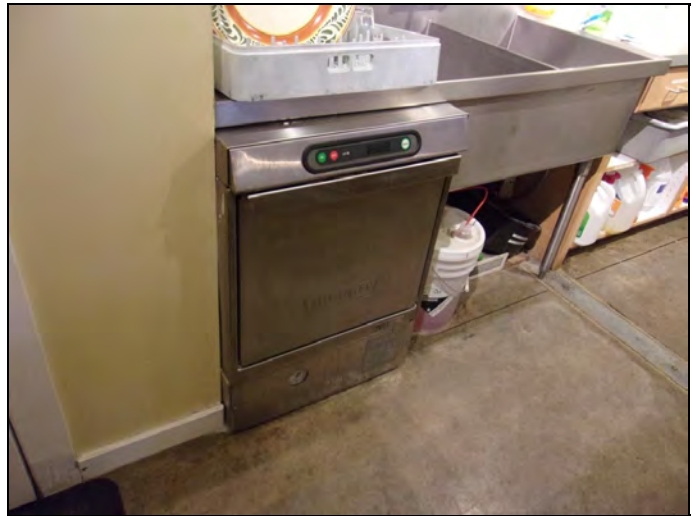
Comp #: 1402 Dishwasher - Replace

The dishwasher is in working condition. We typically recommend funding to replace this component approximately every 15 - 20 years. Remaining life based on current age and condition.

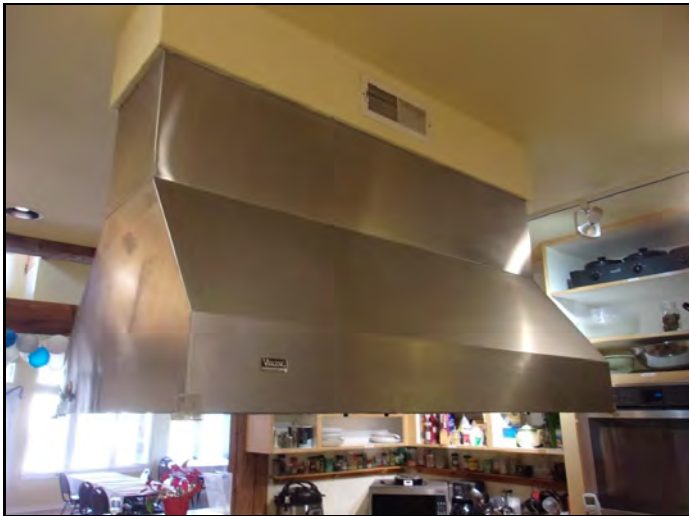
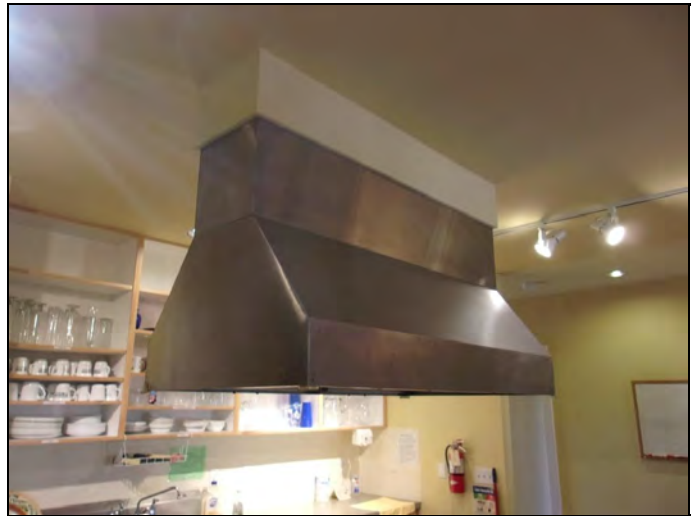
Comp #: 1402 Fume Hood - Replace

The fume hood is in working condition. We recommend funding to replace this component approximately every 15 - 20 years. Remaining life based on current age and condition.

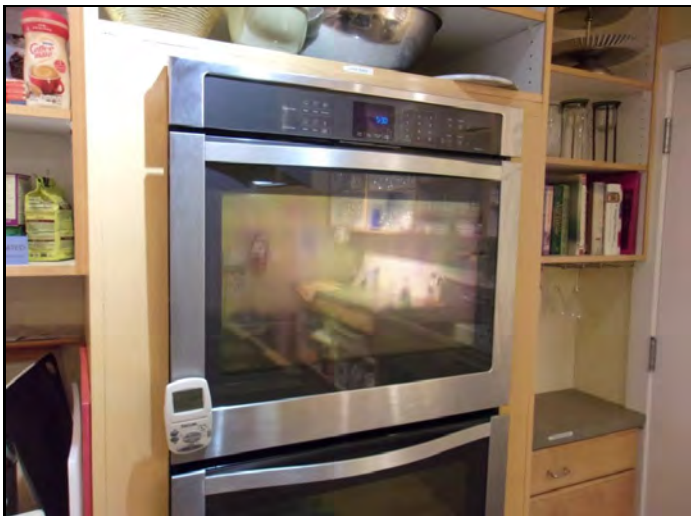
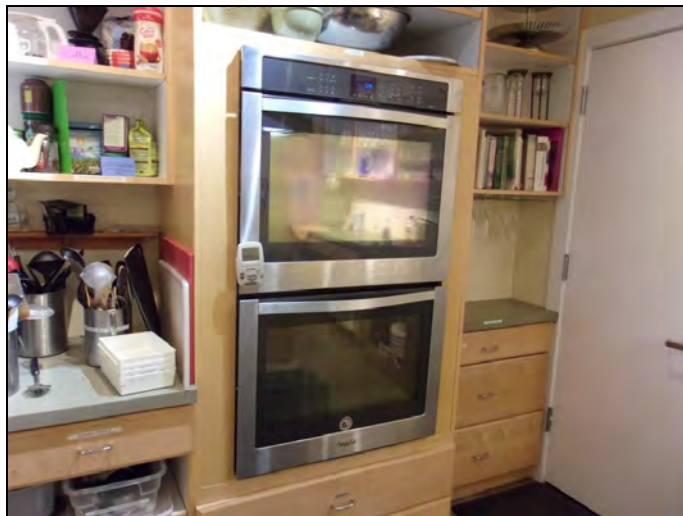
Comp #: 1402 Ovens - Replace

The ovens are in working condition. We recommend funding to replace this component approximately every 10 - 15 years. Remaining life based on current age.

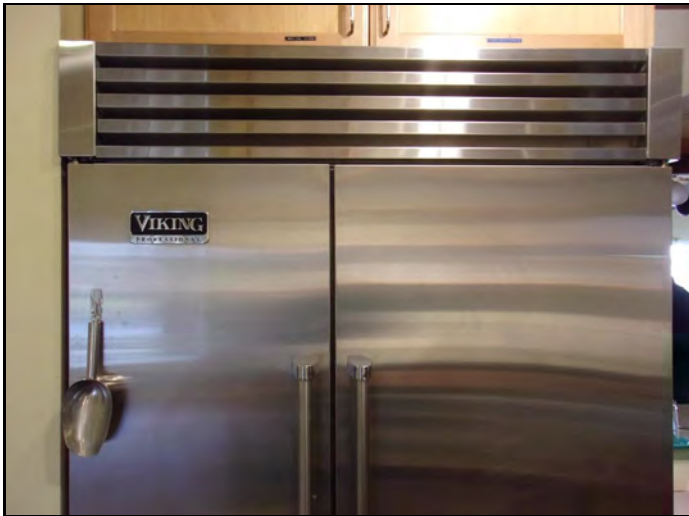
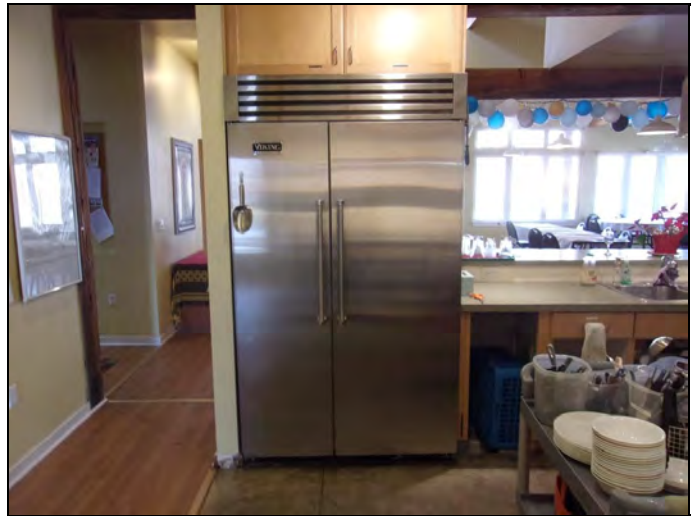
Comp #: 1402 Refrigerator/Freezer - Replace

Research with the client reveals this component is being replaced in 2023. We typically recommend funding to replace this component approximately every 15 - 20 years. Remaining life based on current age and condition.

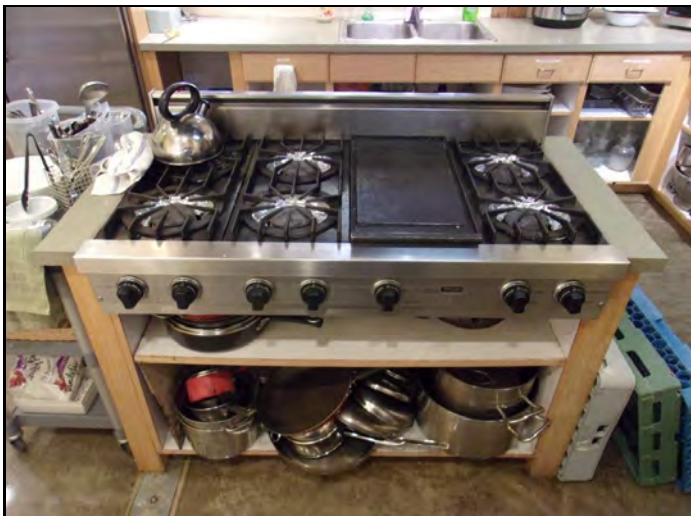
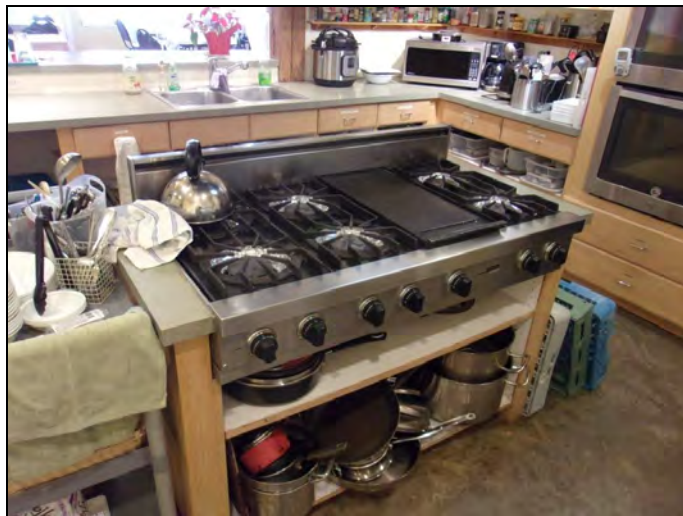
Comp #: 1402 Stove Top - Replace

The stove top is in working condition. We typically recommend funding to replace this component approximately every 15 - 20 years. Remaining life based on current age and condition.

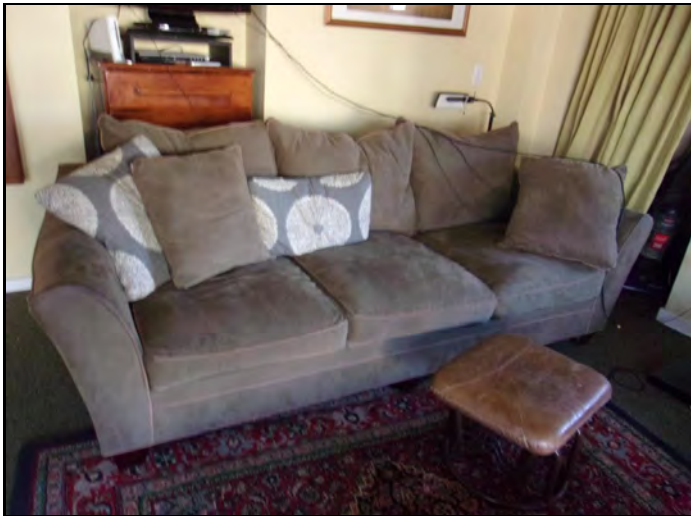
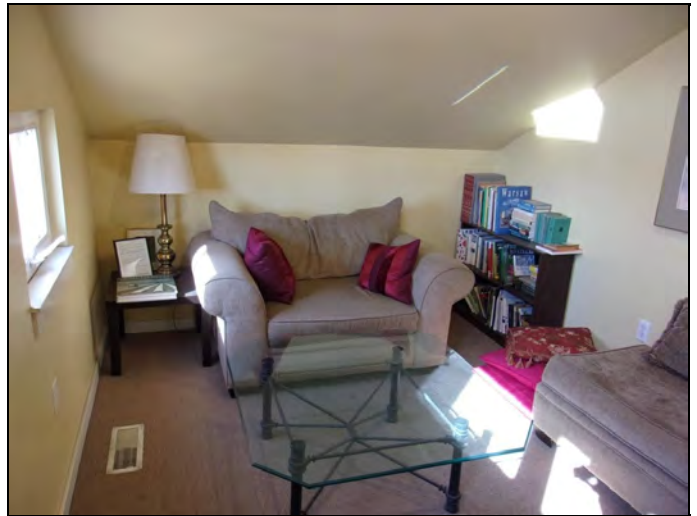
Comp #: 1405 Furniture - Replace

Research with the client reveals this component is replaced as necessary as an operating expense.

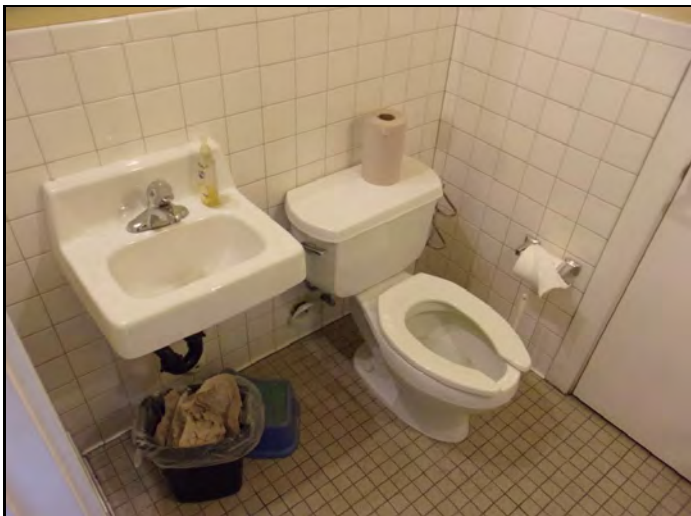
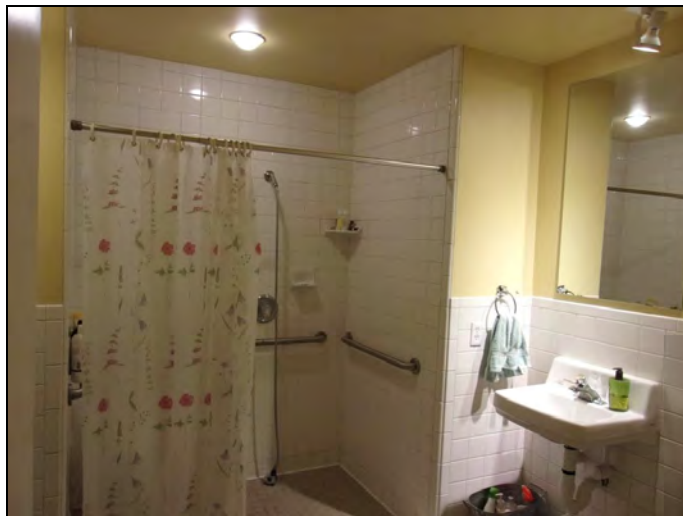
Comp #: 1413 Restrooms - Remodel

The restrooms are in good to fair condition. We recommend funding to remodel this component approximately every 20 years. Remaining life based on current age and condition.

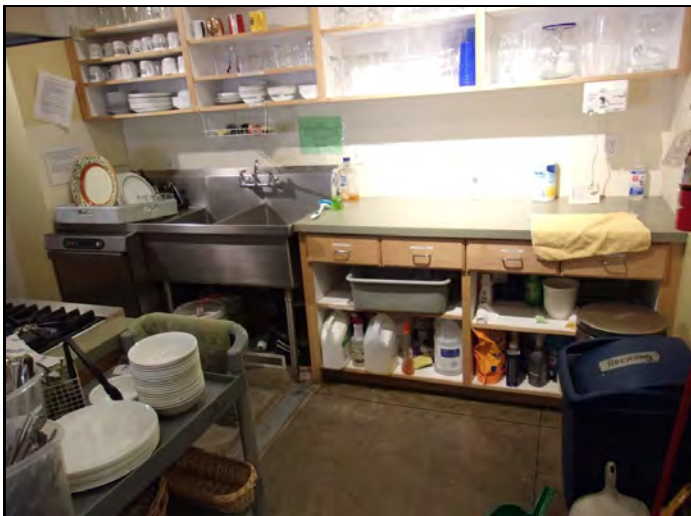
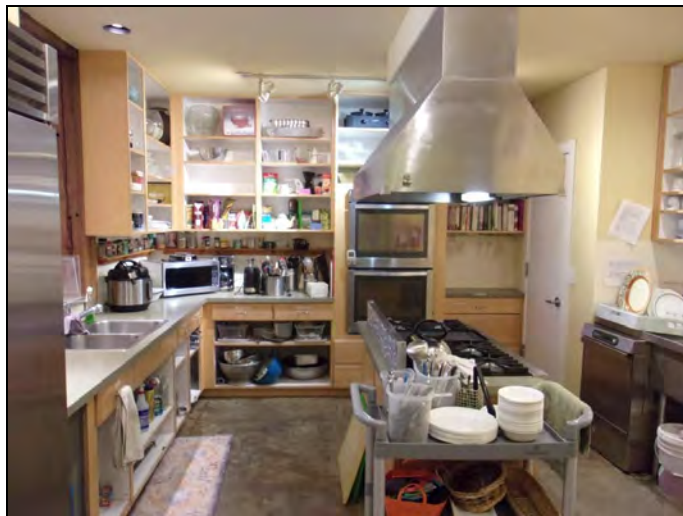
Comp #: 1417 Kitchen - Remodel

The kitchen is in fair condition. We recommend funding to remodel this component approximately every 20 years. Remaining life based on current age and condition.

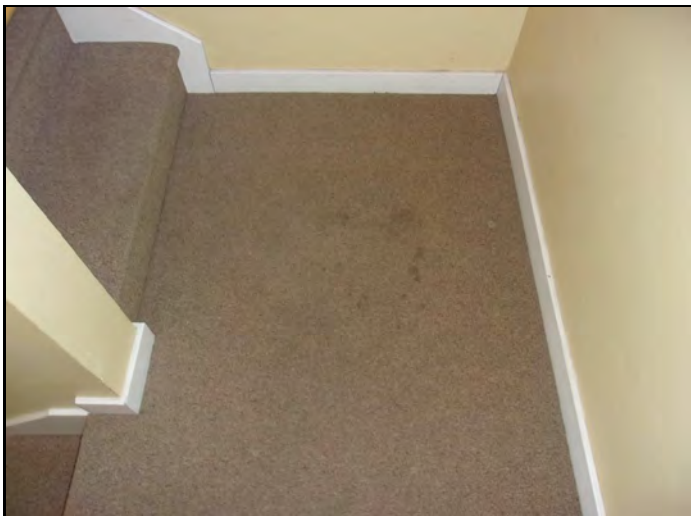
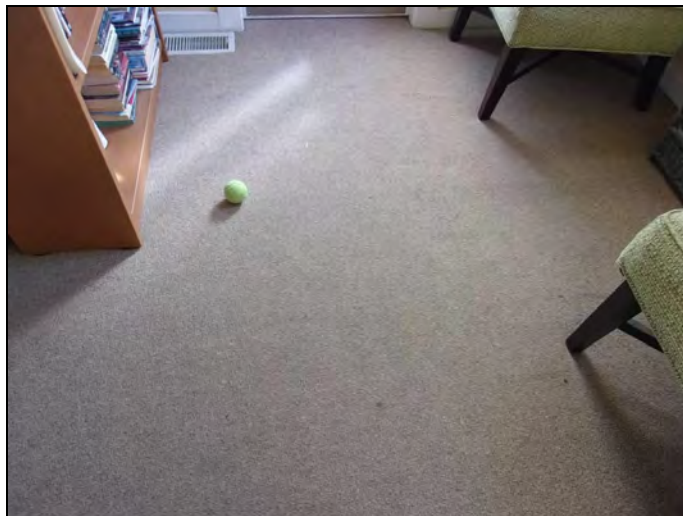
Comp #: 1501 Carpeting - Replace

Research with the client reveals this component will not be replaced until 2025. We recommend funding to replace this component approximately every 8 - 10 years. Remaining life based on current age.

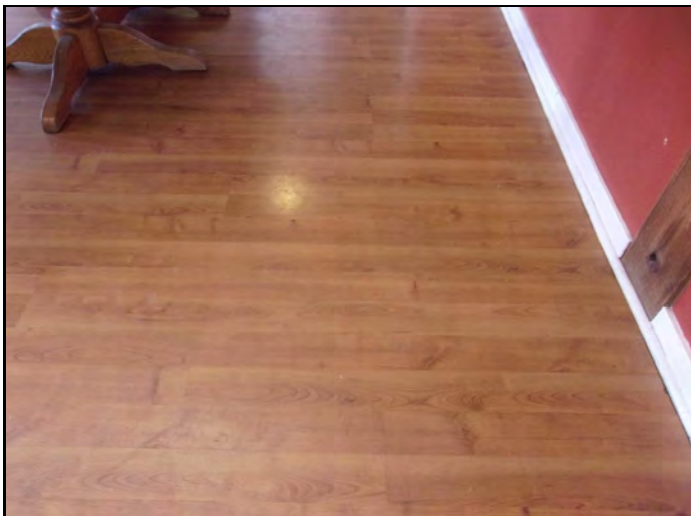
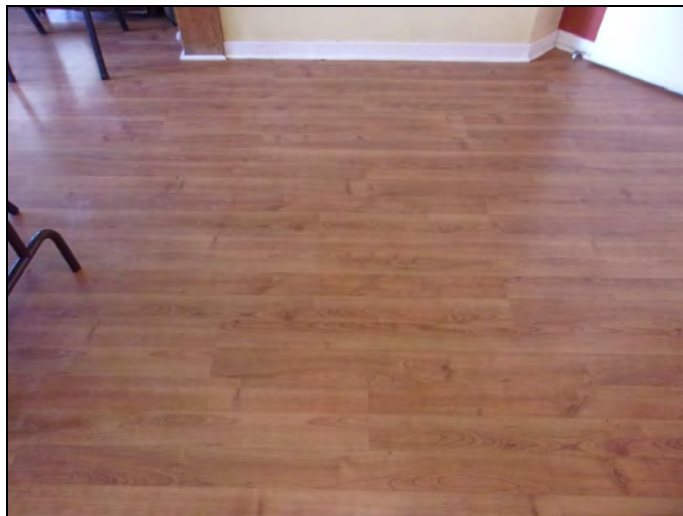
Comp #: 1590 Laminate Flooring - Replace

The laminate flooring is in fair condition. We recommend funding to replace this component approximately every 20 - 25 years. Remaining life based on current age.

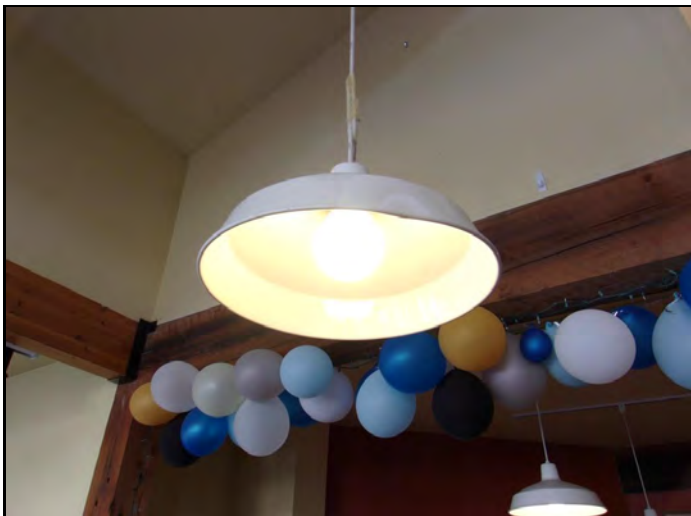
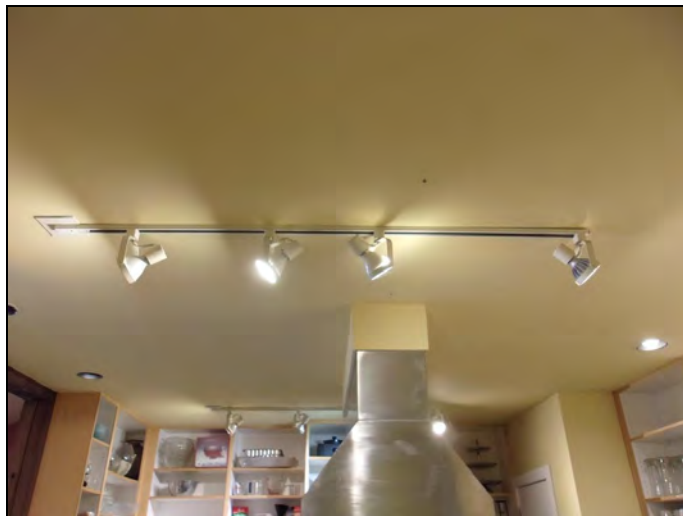
Comp #: 1601 Interior Light Fixtures - Replace

Research with the client reveals this component is replaced as necessary as an operating expense.

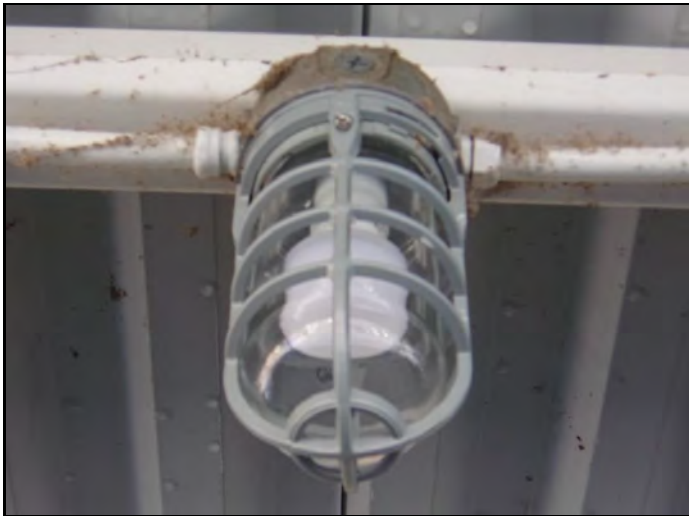
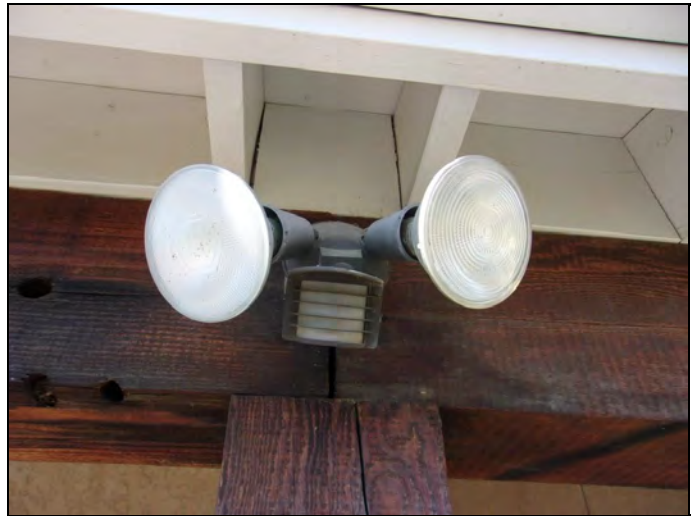
Comp #: 1602 Exterior Light Fixtures - Replace

Research with the client reveals this component is replaced as necessary as an operating expense.

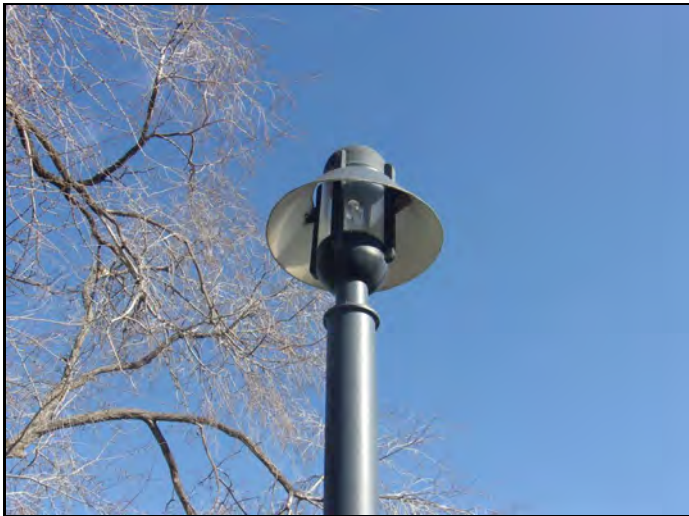
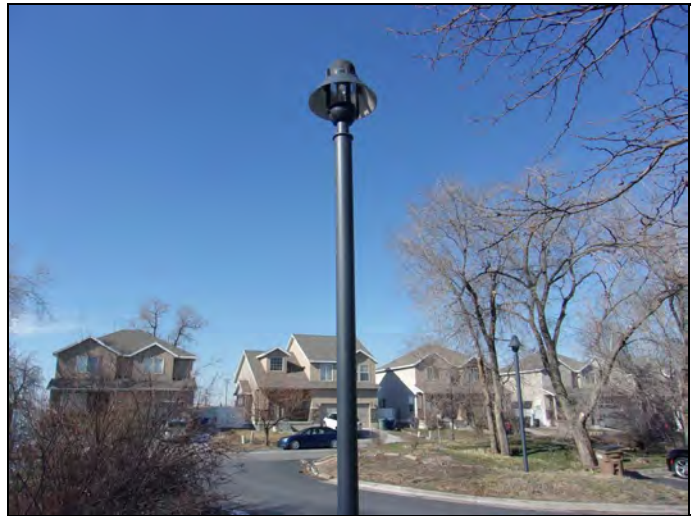
Comp #: 1609 Street Light Fixtures - Replace

Research with the client reveals this component is replaced as necessary as an operating expense.

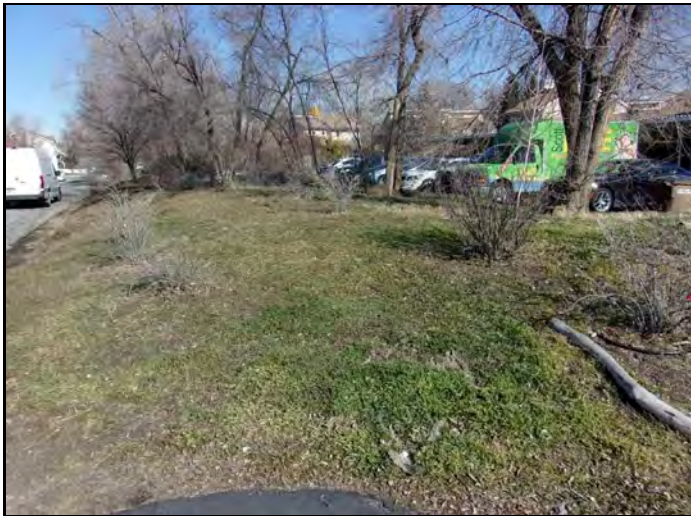
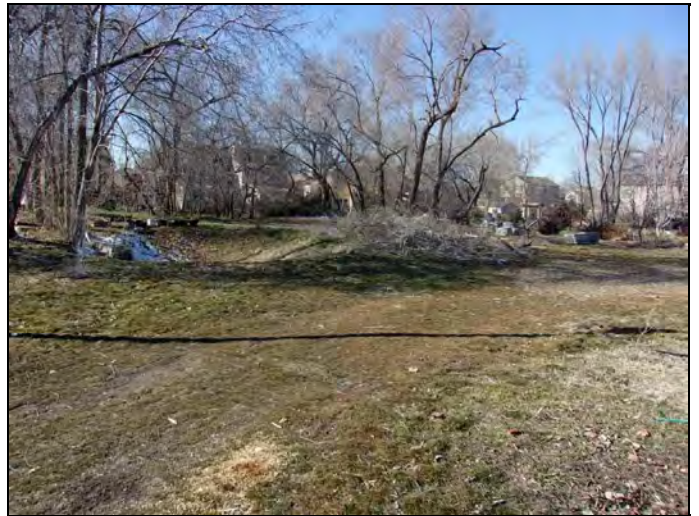
Comp #: 1812 Landscaping & Irrigation System - Renovate

Research with the client reveals this component is replaced as necessary as an operating expense.
